NUMBER: 80-8

DATE: 5/8/80

- A. Steering Link Rod - 1980 Merc 40 thru 140EL
- B. Remote Control Repair
- C. New Style Hydraulic Pump - Proper Filling and Vent Procedure
- D. RPM Loss

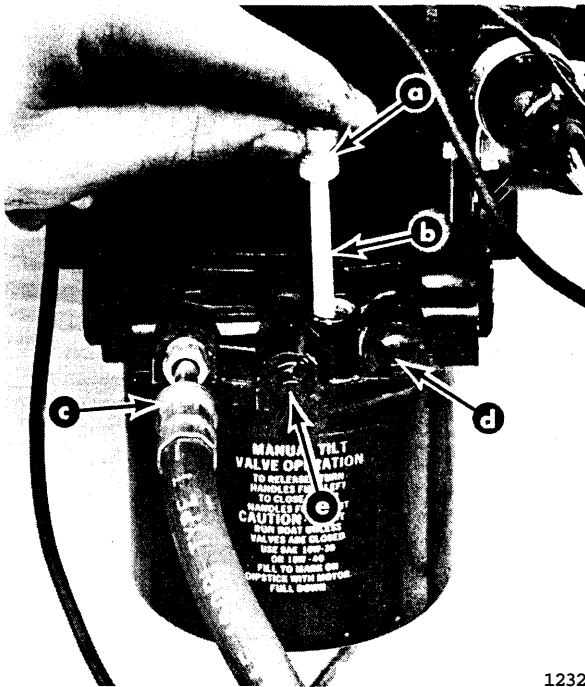
**Figure 1. Hydraulic Trim Pump "Up" Hose Connected**

**IMPORTANT: DO NOT remove "Down" port plug (Figure 1) from pump while filling trim system.**

a - "Fill-Vent" Screw  
 b - Dipstick (Top Line on Dipstick Is "Full"; Bottom Line is "Add")  
 c - "Up" Port Hose  
 d - "Down" Port Plug  
 e - Manual Tilt Knob

1. Check fluid level in pump as follows:
  - a. Place engine in full "down" position.
  - b. Remove "Fill-Vent" screw (Figure 1) and wipe off dipstick with a clean, lint-free cloth.
  - c. Insert dipstick back into reservoir.
  - d. Pull dipstick from reservoir and check fluid level on stick (top line on dipstick is "Full"; bottom line is "Add").

6. Remove "Fill-Vent" screw (Figure 1) and fill pump reservoir to "Full" line on dipstick. Use SAE 10W-40 "SE" automotive oil.
7. Depress "Trailer" tilt button on remote control. Engine will trim up part-way and stop (lack of fluid). At this time, refill pump reservoir to "Add" line (not the "Full" line) on dipstick. Continue this procedure until engine tilts all-the-way up.

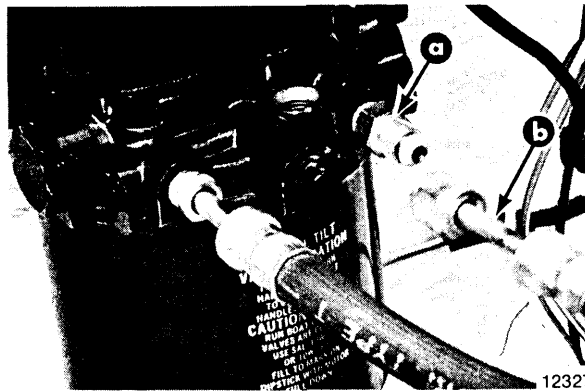
**Figure 2. Connecting "Down" Port Hose to Trim Pump**

a - Hose Fitting Adaptor      b - "Down" Port Hose

8. Remove "Down" port plug from hydraulic pump and thread hose fitting adaptor (Figure 2) into pump. Connect "Down" port hydraulic hose to hose fitting adaptor and tilt engine down by depressing the "In" button on the remote control.

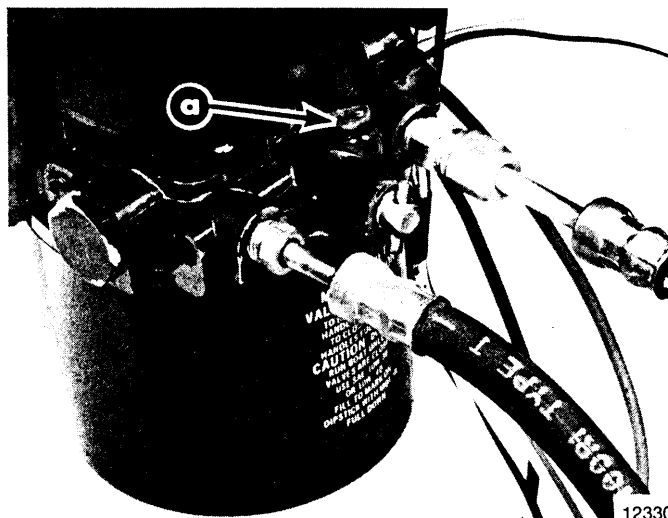
**Figure 3. Both Hoses Connected on Hydraulic Trim Pump**

a - "Fill-Vent" (Turn Screw All-the-Way In and Back Out 1-1/2 Turns; This Vents the Reservoir)

9. Bleed air from hydraulic trim system by operating trim system 3 or 4 times thru entire trailering range, while maintaining fluid in the pump reservoir to the "Full" line on the dipstick. Check fluid level in pump when engine is in full "down" position (see "Important", immediately preceding). Reinstall "Fill-Vent" screw. Turn screw all-the-way in and back out 1-1/2 turns (this vents the reservoir).

**IMPORTANT: "Fill-Vent" screw (Figure 3) must be backed out 1-1/2 turns to vent the reservoir.**
