- A. Model V300/V3.4 Litre Flywheel Torque
- B. Serial Numbers
- C. Spark Plug Fouling - Model V150 and V200

#### C. SPARK PLUG FOULING - MODEL V150 and V200

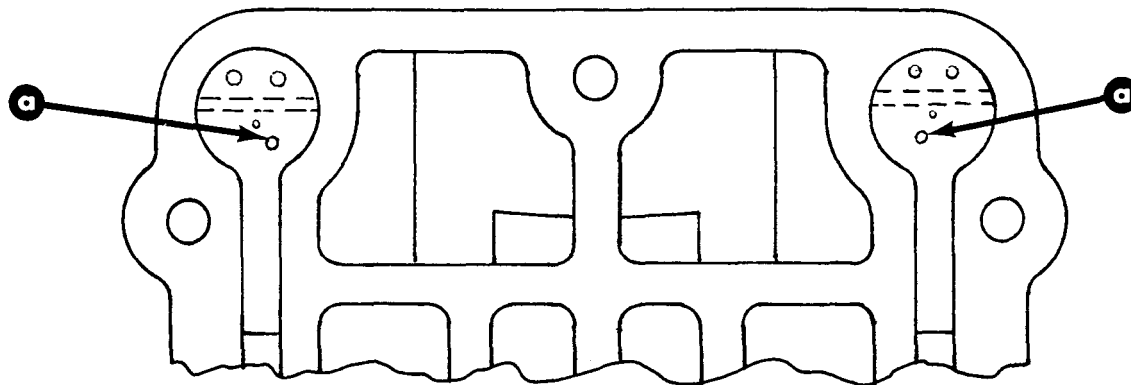
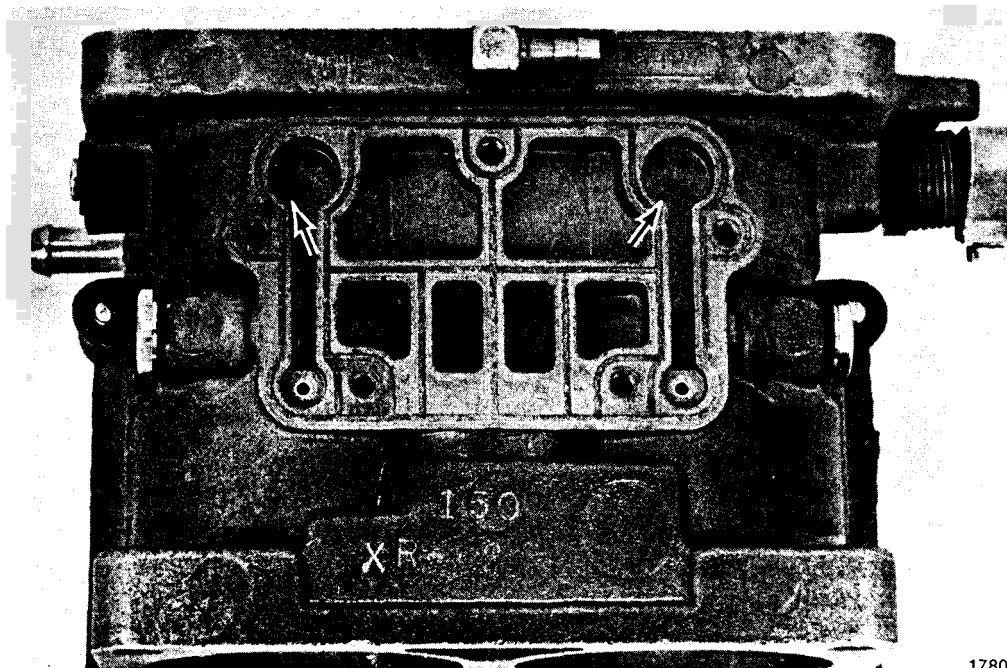
Figure 1.

Should you receive further complaints of low RPM spark plug fouling (after making the above listed adjustments) on Model V150 and V200 outboards, the following carburetor rework is suggested:

**a 2ND PROGRESSION HOLE**

1. Using a hand held pin vise, enlarge the second progression to .052 (Figure 1).
2. Install .056 idle jets. (Rejet the idle circuit as noted in Step 2 preceding.)

1. Using a hand held pin vise, enlarge the second progression hole to **.046** (Figure 1).
2. Install .056 idle jets. (Rejet the idle circuit as noted in Step 2 preceding.)
