service bulletin

- A. Fuel Line Kinking 1987-88 Model 3 Cylinder 70-75-80-90-HP
- B. E.C.U. Harness Coupling Ring V220 EFI
- C. Gear Housing Change Mariner 25 (695) and 30 (689)
- D. Propeller Shaft Change Mariner 25 (695) and 30 (689)
- A. FUEL LINE KINKING 1987–88 MODEL 3 CYLINDER 70–75–80–90 HP

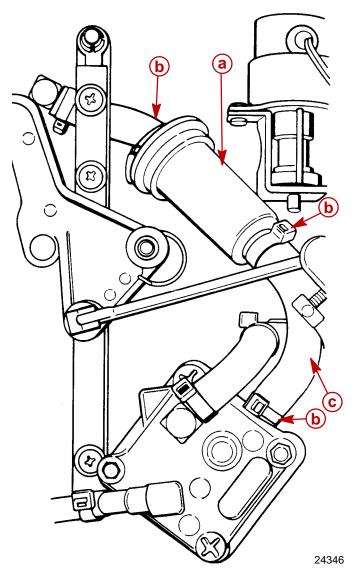
Figure 1. Molded Hose Kit Installed

On 1987–88 3 cylinder (70–75–80–90 HP) the fuel line between the fuel pump and fuel filter may kink and restrict the fuel supply to the carburetors. Should this occur, replace the original fuel line with Molded Hose Kit P/N 32–19017A1. (Figure 1) Kit contains a molded fuel line and a replacement fuel filter.

- a Fuel Filter
- **b** Sta–Strap (Three Places)
- **c** Hose (Pump to Filter)
