## 220 EFI

#### A. DESIGN IMPROVEMENTS

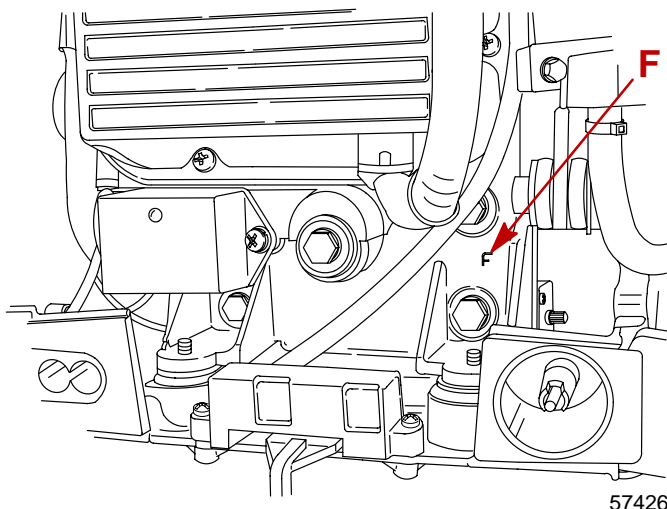
Figure 1.

**NOTE:** The letter "F" or three centerpunch marks on the lower front of the fuel management system indicates the injector filters were removed. Figure 1 (22771).

1. Vent vapor separator to the atmosphere. Service Bulletin 87-7, page 1, item 2, High Speed Surge.
2. Remove **white** injector filters. Service Bulletin 87-12
