- A. 91-13664 Bearing Carrier Tool – 6, 8, 9.9 & 15 HP Models
- B. Commander 2000 Remote Control Warning Horn Buzzing – 3 Cylinder Model 70-75-80-90 and 4 Cylinder Model 100
- C. Modified Propeller for Trouble-Shooting Mag II/XR 4 Models
- D. E.C.U. Test Readings – Mariner/Mercury 220

A. 91-13664 BEARING CARRIER TOOL 6, 8, 9.9 & 15 HP MODELS

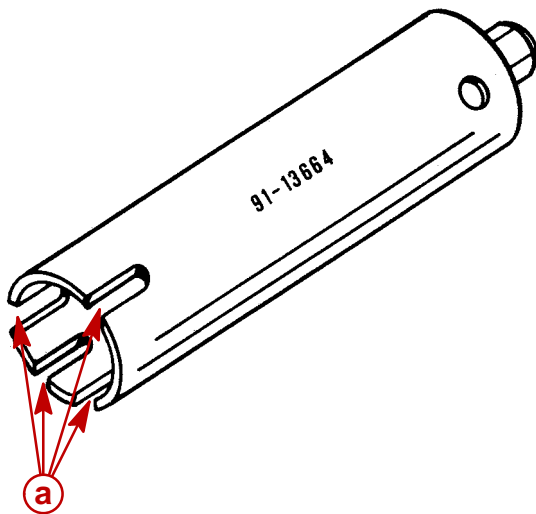
The four (4) slots in the tool must have the widths increased by 1/8" for a total of 7/16". Refer to drawing below.

a - 4 Slots Original Width 5/16" Increase Width to 7/16"

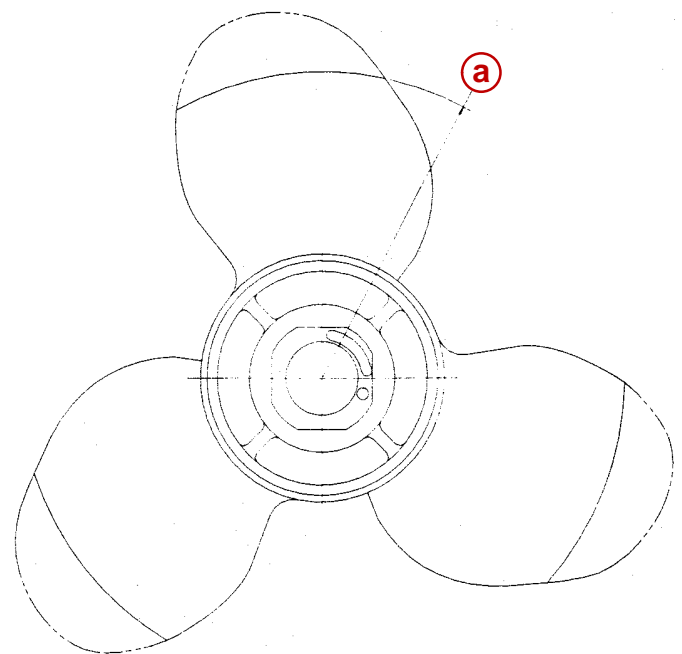
Modified Propeller

It is possible to make a test propeller by modifying a standard aluminum propeller to assist in trouble-shooting Mag II/XR4 models. This modified propeller allows wide-open-throttle operation while the boat is stationary in the water and **secured** to a dock or trailer. Modification consists of reducing the diameter of a 48-77340A40 (14" x 13") propeller to 12 inches. Any prop repair station can make the modification.

a - 6 inch (152mm) Radius
