- A. Choke Shutter Interference - 1989-1/2 Mercury 35 Electric Start
- B. Parts Manual Volumes
- C. Decals Available - Mariner/Mercury 6/8/9.9/15 Models
- D. Rough Water Operation - XR4 and Magnum II Outboards

A. CHOKE SHUTTER INTERFERENCE - 1989-1/2 MERCURY 35 ELECTRIC START

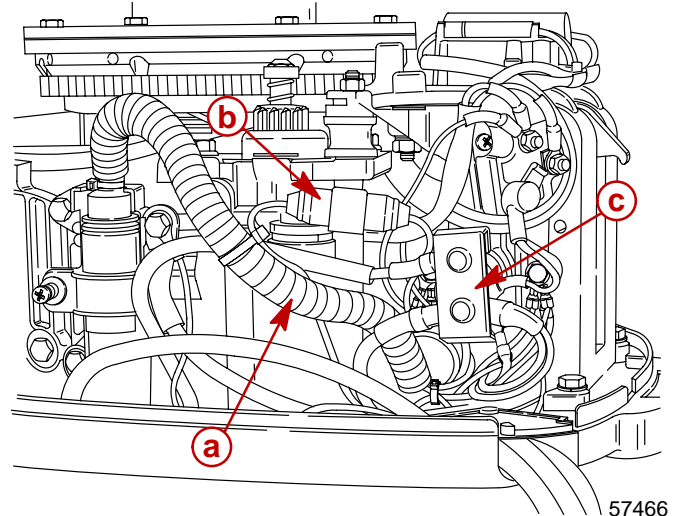
Figure 1. Beginning 1989 1/2 Wire Routing

Electrical wire routed incorrectly may contact and restrict choke shutter movement on models listed. Restricted choke shutter movement may cause:

- **Hard Starting** by preventing full choke shutter closing
- **Rich Running** by preventing full choke shutter release

- a - Wire Harness
- b - Fuse Holder
- c - Solenoid

Beginning 1989 1/2 Models (Figure 1)—Reroute wire harness above fuse holder and solenoid as current models are routed (Figure 2) and secure to front cowl support rubber mount with sta-strap (P/N 54-90077). Install second sta-strap around front cowl support bracket and electrical wires to hold all wires forward and away from choke shutter area (Figure 3).

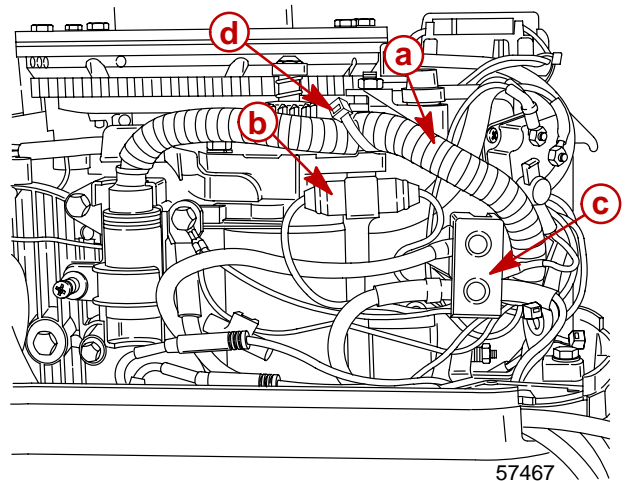
Figure 2. Current 1989 1/2 Wire Routing

- a - Wire Harness
- b - Fuse Holder
- c - Solenoid
- d - Sta-Strap Around Wire Harness and Rubber Mount

Current 1989 1/2 Models (Figure 2) — Install sta-strap (P/N 54-90077) around front cowl support bracket and electrical wires to hold all wires away from choke shutter area (Figure 3).

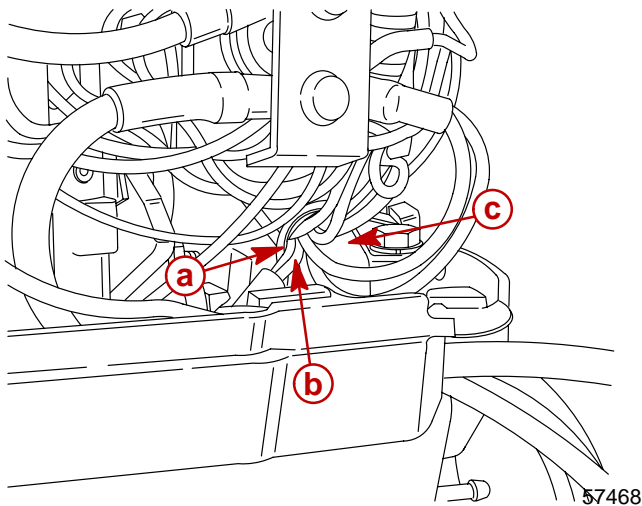
Figure 3. Sta-Strap Location

- a** - Sta-Strap
- b** - Wires Held By Sta-Strap
- c** - Front Cowl Support Bracket
