1989 Model V6 Outboards – 40 AMP Charging System

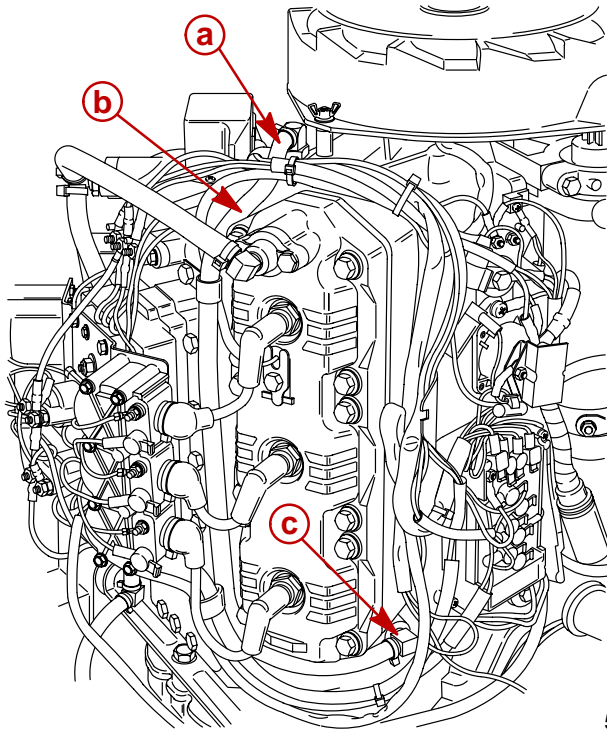
Figure 1.

Recently a concern was discovered in cooling the watercooled voltage regulator for the 40 amp charging system. It was found that prolonged idling could allow a steam pocket to grow in the cylinder block, to the point that the cooling fins, on the bottom of the regulator, are not fully submerged in water. While this does not effect the operation of the outboard, the regulator has a thermo-safety switch built in. Therefore, if the regulator temperature gets to a critical point it shuts off the charging system which over a period of time could result in a discharged battery.

To solve this problem, route the poppet bypass water out the top of the block and eliminate the 3/8" hole at the bottom of the block. This will route the water externally back into the poppet valve area thru a fitting in the relief valve cover. (Figure 1) This will eliminate this situation at all engine speeds.

A Water Bypass Kit P/N 814654A1 is available for this modification. Should a customer indicate that their battery is not charging properly, it may be necessary to install the bypass kit. This installation of the kit will be covered under warranty.
