Oil Injection Pump Sport Jet

Models Affected

1995 SPORT JET 90 & 120
S/N 0E125390 - 0E141088

1996 SPORT JET 95XR & 120XR
S/N 0E141089 - 0E200011

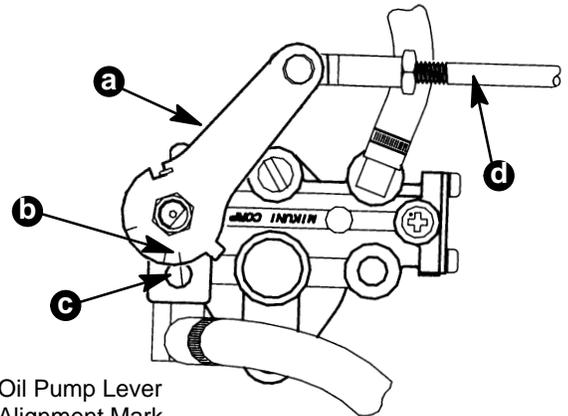
There have been sporadic reports of Sport Jet powerheads scoring pistons during the break-in period. Engineering had found that the oil injection pump has not been consistently adjusted to provide the correct ratio of oil at wide open throttle. Several engines were found where the oil injection pump was metering oil at 70:1 rather than 50:1.

This was caused by a change where the fixed wide open throttle stop was replaced by an adjustable stop. The adjustable stop was necessary to increase the idle timing to achieve the 1000 rpm idle speed with a closed throttle shutter. The closed throttle shutter is a requirement for the Turn Key Start feature.

- a - Oil Pump Lever
- b - Alignment Mark
(At Wide Open Throttle)
- c - Pump Alignment Mark
- d - Link Rod

1. Move towershaft to the Wide Open Throttle position. Inspect oil injection pump alignment mark (c) with the oil pump lever mark (b). This check may require the use of a small mirror.

2. Adjust oil pump link rod (d) to align the marks as necessary.
