Low Ignition Voltage Output: 135-200 Mercury/Mariner Outboards with 40 Amp Charging System

This is a revision of Outboard Service Bulletin 91-2. Destroy Bulletin 91-2 and insert Bulletin 91-2A. Revisions are underlined.

1989-1991 Mercury/Mariner 135-200

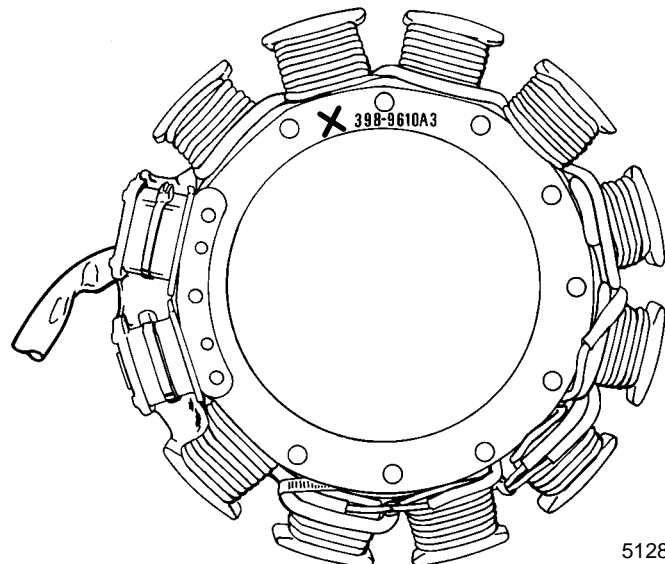
51283

Any 40 amp stator (P/N 398-9610A5) in your service stock marked with an "X" by the part no. on the stator, or dated after 1-1-91 have been tested at the factory. Stators without the "X" which are dated before 1-1-91 should be tested for proper ignition voltage output when installed on engine.
