## service bulletin

No. 92-14

## Stronger Spark Advance Spring P/N 24-823235 - 135 thru 200

Mariner and Mercury

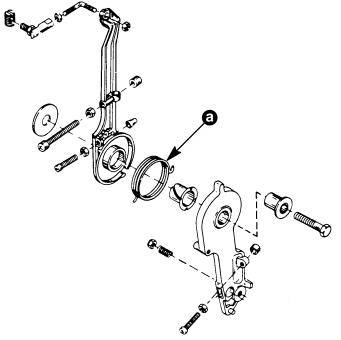
Figure 1. Throttle/Spark Arm Assembly

Starting with s/n 0D187699 a stronger spring p/n 24-823235 is installed in the throttle/spark arm assembly. The stronger spring will ensure proper spark advance during acceleration. With the previous weaker spring, the spark arm may not have enough force to move the trigger if it is binding or the trigger wires are not routed properly or are pulled too tight. A trigger that sticks or moves too slow may cause bogging during acceleration or general poor performance.

a - Spark Arm Spring

The slow moving trigger problem may go back to the models produced in 1990 when we removed the "U" shaped spring and changed the spark arm spring to reduce excessive throttle force. Refer to Service Bulletin 89-16A.

Adjust the trigger wire slack by moving the wire in the "J" clip at the back of the block.

Replace existing spark arm spring with the stronger spring p/n 24-823235.
