Quicksilver Propeller Failures and Guidelines

Mercury, Mariner and Force
All Quicksilver Propellers

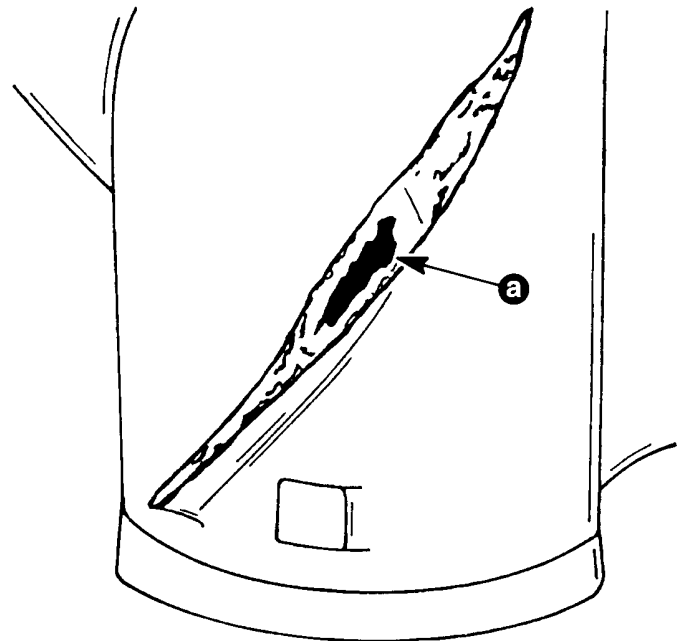
1. Loss of Blade

The picture below shows a propeller with blade failure. This failure is a result of a casting void (a). This is a true defect in material.

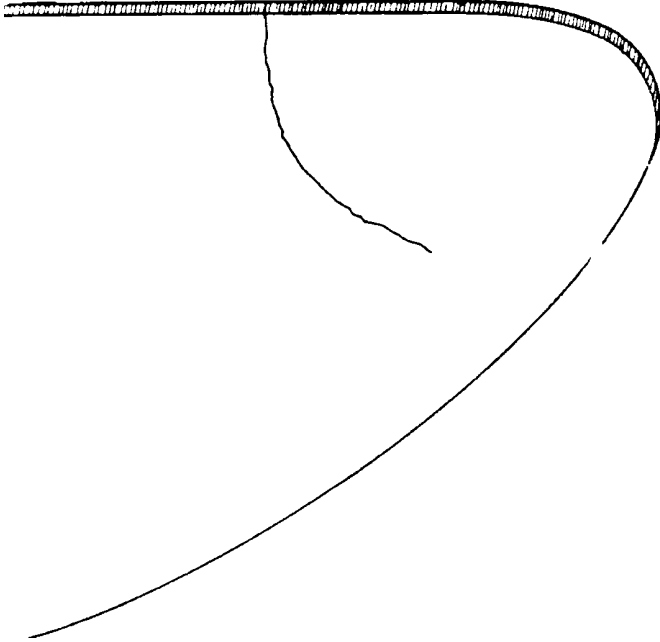
2. Trailing Edge Blade Cracks

The picture below shows a propeller blade with blade failure. This failure is a result of a fatigue crack. This type of fatigue failure starts at the trailing edge of the propeller and works its way to the leading edge. This type of failure can be caused by cup modifications, improper repairs, impacts and blade flex. Blade flex is the only possible warrantable condition among the aforementioned causes. Failure caused by cup modifications, improper repairs, or impacts are not covered by Quicksilver warranty.

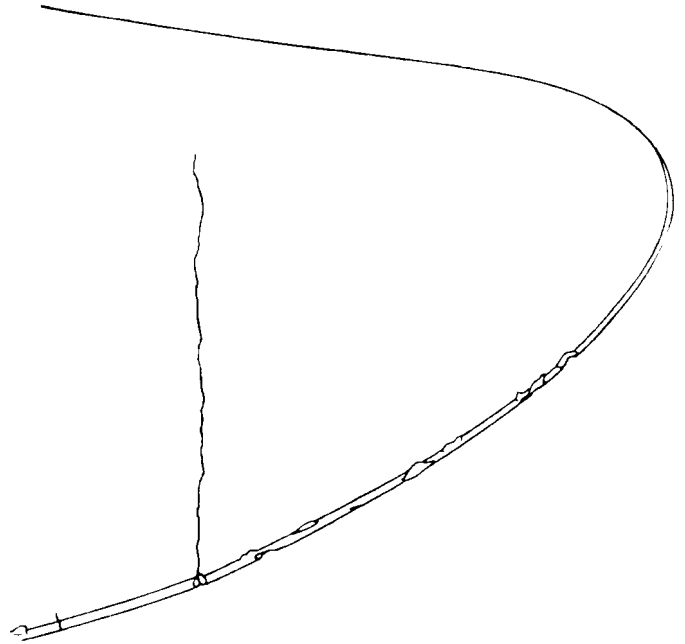
3. Leading Edge Blade Cracks

Pictured following, is a propeller with a fracture line starting at the leading edge of the blade. Leading edge fatigue cracks are caused by impacts with objects in the water, often not even detected or observed by the operator. Small nicks on the leading edge, if left undressed, can cause fatigue cracks. These types of fatigue cracks start at the leading edge and work their way back to the trailing edge. This type of failure is normally seen on thin blade propellers (High Five, Laser

II and Choppers). Fatigue cracks starting on the leading edge are not covered by Quicksilver warranty. The owner may wish to report this type of fatigue failure to a casualty insurer inasmuch as they are impact failures.
