## STA-STRAP and LINK ROD INTERFERENCE - 75 THRU 115

### MARINER AND MERCURY

75 thru 115

S/N 0D163572 thru 0D176524

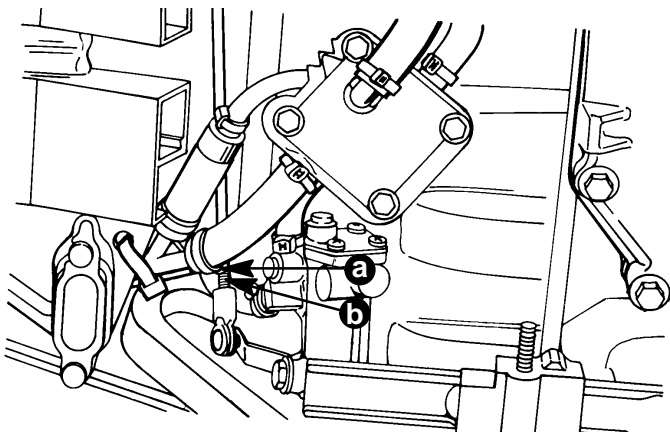
**Figure 1. Incorrect Sta-Strap Position**

The models listed may have a fuel line sta-strap installed in a position which allows the locking tab to contact the oil pump link rod. If sufficient contact occurs, the carburetor throttle plates may not be allowed to return to the closed position and results in a higher than desired idle speed. The locking tab of the fuel line sta-strap must be positioned away from the oil pump link rod to avoid contact.

a - Sta-Strap Locking Tab  
b - Oil Pump Link Rod

Inspect outboards listed for sta-strap and oil pump link rod interference. Correct by repositioning the existing sta-strap or by installing a new sta-strap with the locking tab away from the link rod.

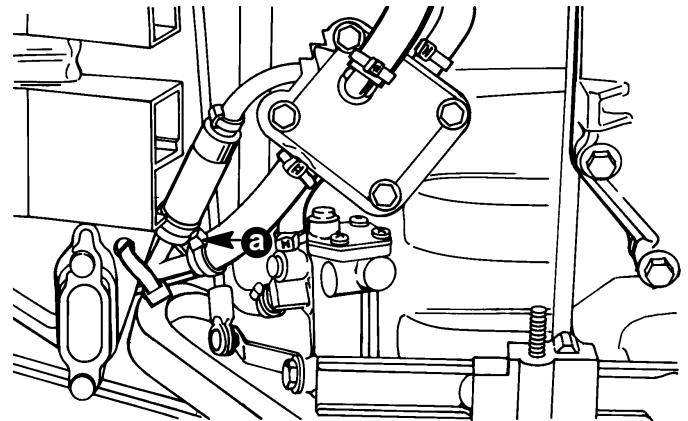
**Figure 2. Correct Sta-Strap Position**

a - Sta-Strap Locking Tab
