Lean Condition Between 2000 and 3500 RPM - 135 Thru 200

Mariner and Mercury

1990 thru 1992

S/N 0C221500 thru 0D181999

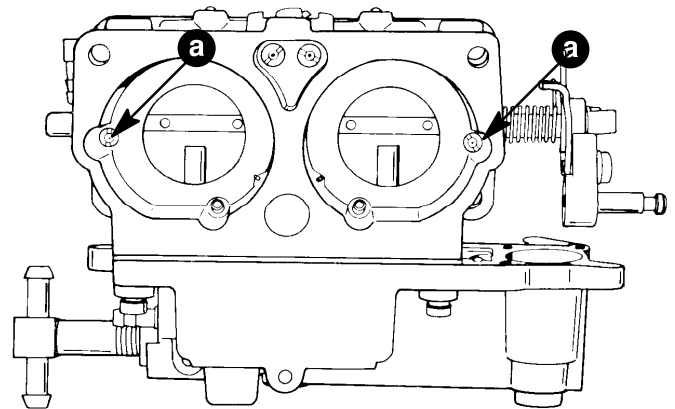
Figure 1. Jet Location

ENGINE GRADUALLY LOSING ENGINE SPEED AND EVENTUALLY QUILTS RUNNING may be caused by incorrect progression air jets. Only 1991 and 1992 carburetors listed below are suspect to the lean condition that causes the engine to loose RPM and eventually quit.

Correct the lean condition by change the existing progression air jet in all three carburetors from 0.070 to 0.048 inch. Part number of the 0.048 jet with 8-32 thread is 815633048. Six (6) jets are required per engine.

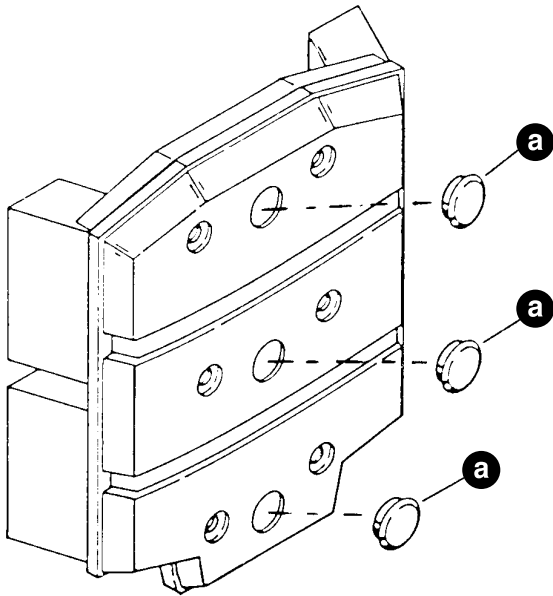
Figure 2. Attenuator

ENGINE LEAN SURGING may be caused by increased vacuum created in the air box.

REMOVE THE THREE PLUGS IN THE FRONT OF THE ATTENUATOR.
