# service bulletin

No. 93-20

## 1994 225 Update

1994 225

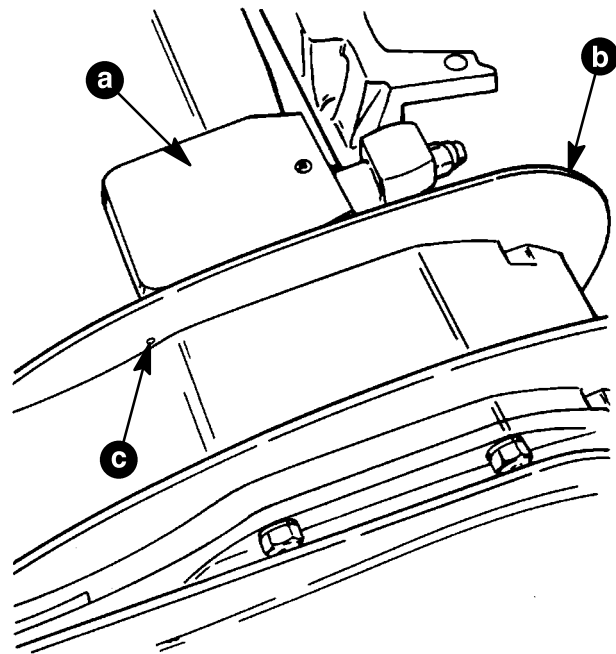
**Figure 1. Drain Hole Location View.**

Inspect and, if necessary, remove the thin layer of aluminum covering the drive shaft housing drain holes. The drain holes are 1/8 inch (3.2 mm) in diameter. They are located under the splash plate on BOTH sides of the drive shaft housing and directly below the rear edge of lower mount cover. The holes allow water to drain from around the exhaust tube, when the engine is not running.

Failure to allow the water to drain from the cavity will cause the drive shaft housing to:

- corrode prematurely on the inside of the cavity in salt water.
- crack/break due to the formation of ice when exposed to freezing temperatures.

If either of the drain holes are not open, use the template provided to locate and open the drain holes. One template is provided for use on both sides of the drive shaft housing. Cut the template on the dotted line, punch a small hole in the center of the hole location dot, position the template on the drive shaft housing and mark the hole locations on BOTH sides of the drive shaft housing.

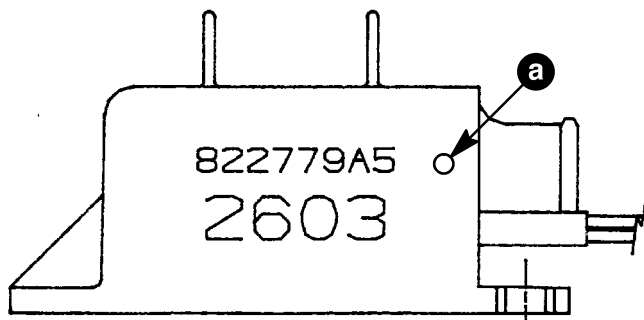
Figure 3. Side View of CDM.

- a. - Location of White Dot.

Replace all six CDM's. The improved CDM's are marked with a white dot after the cast-in part number or have a date code 2603 and above. Service part number is 822779A-2.

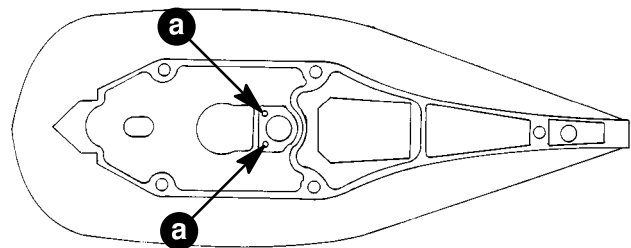
Figure 4. Bottom View of Drive Shaft Housing.

- a. - Drill Two .250 Inch (6.4 mm) Holes.

Remove the gear housing and drill two 0.250 inch (6.4 mm) water inlet holes. Drill the holes from the bottom side of the drive shaft housing in the flat area of the housing forward of the water tube. A drill extension or 12 inch (304.8 mm) long drill is required.

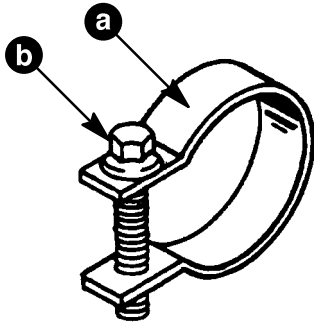
**Figure 6. Alternator Plug Clamp**

- a. - Clamp P/N 826188
- b. - Screw P/N 10-821045-20

Install clamp and screw on the alternator electrical plug to prevent movement, due to vibration. Screw torque is 27 Lbs. In. (3 N-m).

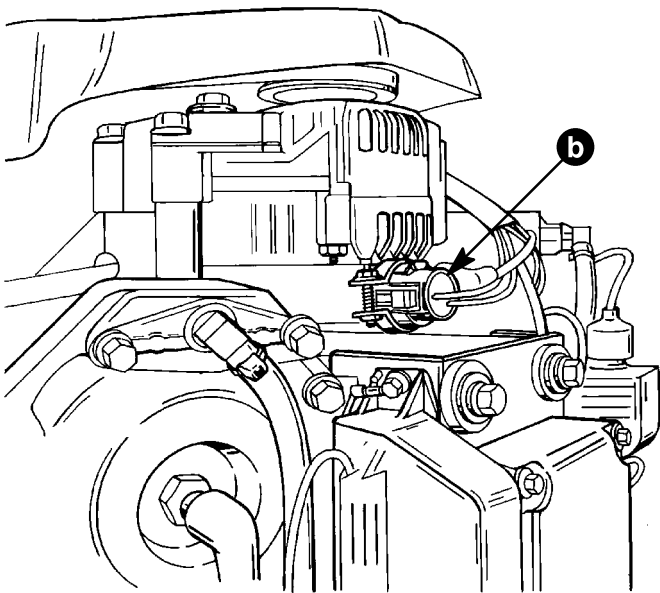
**Figure 7. Alternator Plug Location.**

- a. - Clamp Position.
- b. - Alternator Plug.
