Power Trim Leak Down - 40 Thru 115

This is a revision of Outboard Service Bulletin 93-22. Destroy Bulletin 93-22 and insert Bulletin 93-22A. Changes are underlined>.

Mariner And Mercury

1993 and 1994 40 Thru 115

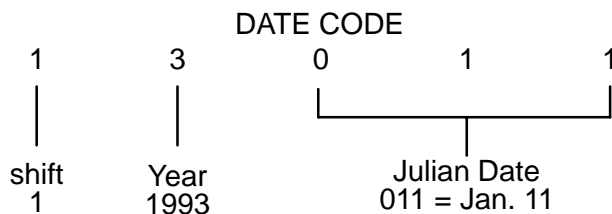
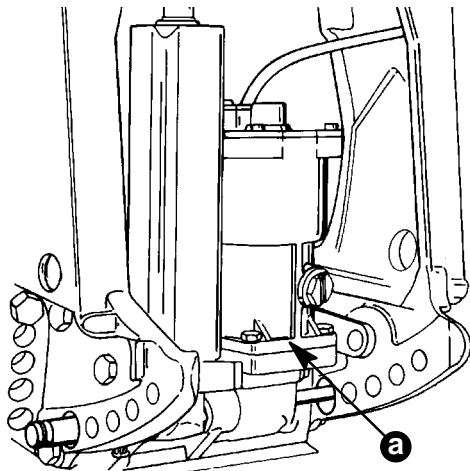
Figure 1. Date Code Location.

a - Date Code

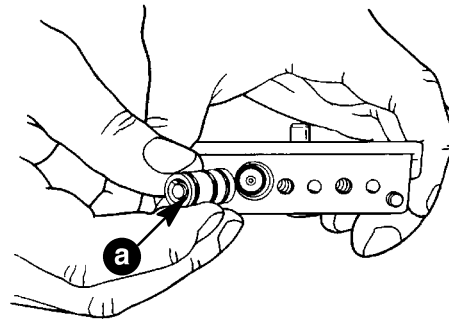
Figure 2. Side View of Manifold.

a - Sleeve with Spool Inside.

To correct, remove the tilt cylinder from the manifold and replace the pilot valve assembly as outlined in the outboard service manual. It is NOT necessary to replace the complete power trim to correct the problem.

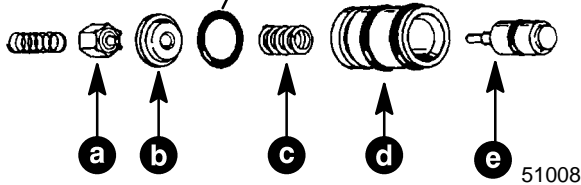
Figure 5. Pilot Valve and Seat Removal.

- a - Pilot Valve.
- b - Valve seat.
- c - Return Spring.
- d - Sleeve.
- e - Spool.

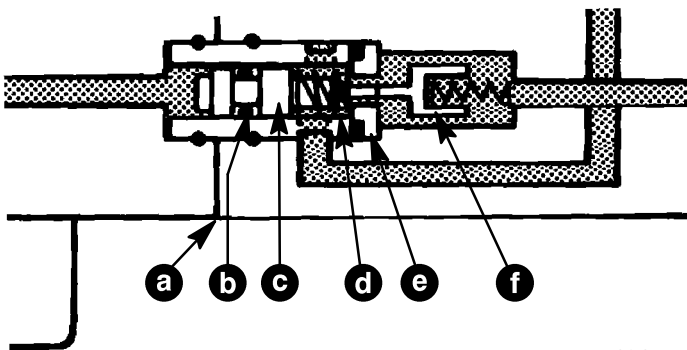
Figure 6. Pilot Valve Held Open.

The 1993 and 1994 models listed with power trim date codes 13011 thru 23288 ONLY may experience a very slow up trim rate (one minute or more) with the outboard drifting back down as soon as the UP trim button is released. This failure usually occurs when the unit is new or after three or four weeks of non use. The cause may be a stuck spool inside the sleeve due to an oversize or a hard O-ring on the spool.

A leak path is created between the UP side of the cylinder and the reservoir, when the spool sticks holding the pilot valve open.

- a - Cylinder/Manifold Mating Surface.
- b - O-Ring in Question.
- c - Spool.
- d - Return Spring.
- e - Valve Seat.
- f - Pilot Valve Held Open (away from valve seat).

Power trim units with date code 23289 and higher have improved O-rings and improved surface finish on the inside of the sleeve to correct the problem.

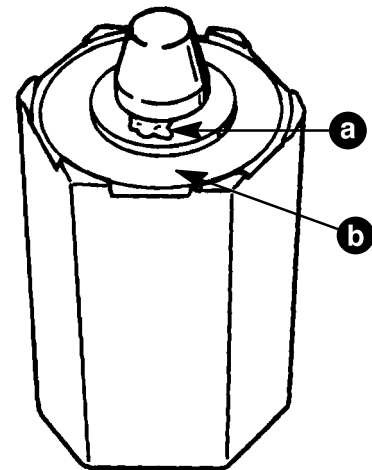
Figure 7. Pilot Valve End.

- a - Chip Under Valve Tip.
- b - Rubber Seat.

To correct a slow leak down, check for debris between the valve seat and valve.
