## Rich Idle Condition- Sport Jet 90

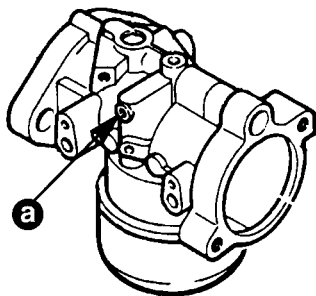
a - Fuel Bowl Vent

Have received random reports of idle problems: rough idle and poor acceleration. These reports were communicated to us by dealer service personnel checking out new boats with the Sport Jet 90 units. They found the inlet needles on the carburetor were not shutting off the fuel when the fuel bowls were full, flooding the engine. This was caused by debris (pieces of fuel hose or paint chips) lodged between the needle and seat.

Normally this is easy to spot on an outboard motor because fuel would spurt out the elbow vent of the carburetor (a). But, in the case of the Sport Jet carburetors, this condition cannot be visually seen. The venting is done through a fitting in the bowl vent of each carburetor and routed through a black colored hose to the top of the carburetor cover.
