Powerhead Water Ingestion - 225 Model

Mariner and Mercury

1994 and 1995
225 hp Models
S/N 0D280813 thru 0G178947

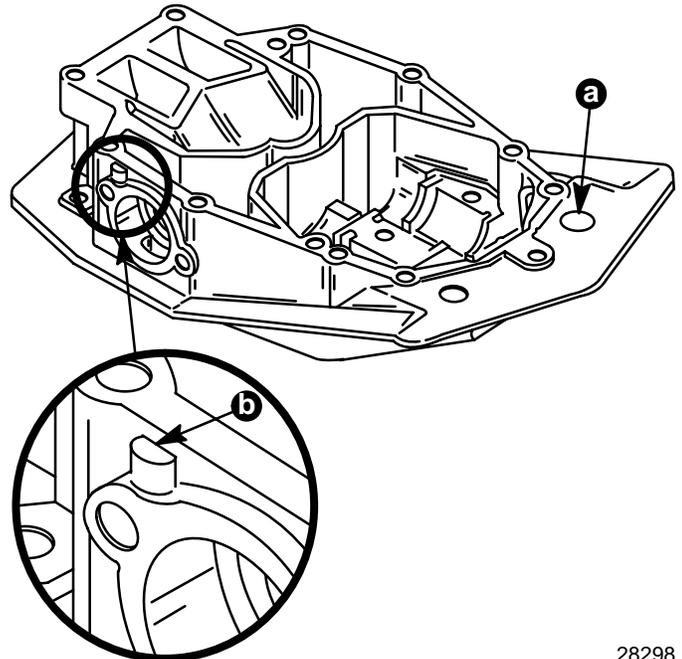
Figure 1. New Exhaust Adaptor Plate.

Some outboards within this serial number range were modified at the factory. Factory modifications and some early field modifications have the new exhaust adaptor plate p/n 818450A-1 installed. The new adaptor plate is identified with a raised boss above the poppet valve opening and p/n 818450C-2 is cast in the front of the plate as shown in figure 1.

a - Casting Number 818450C-2
b - Raised Boss

1. Paint a white paint dot on the exhaust adaptor plate above the poppet valve. Paint in the same location as the raised boss on the new adaptor plate. Refer to figure 1.
2. Operate the outboard. Check and correct any water leaks or other problems noted.
3. Clean salt deposits, touch-up paint as required.
4. Verify that updates per Service Bulletin 93-20 have been completed. Complete these updates as required.

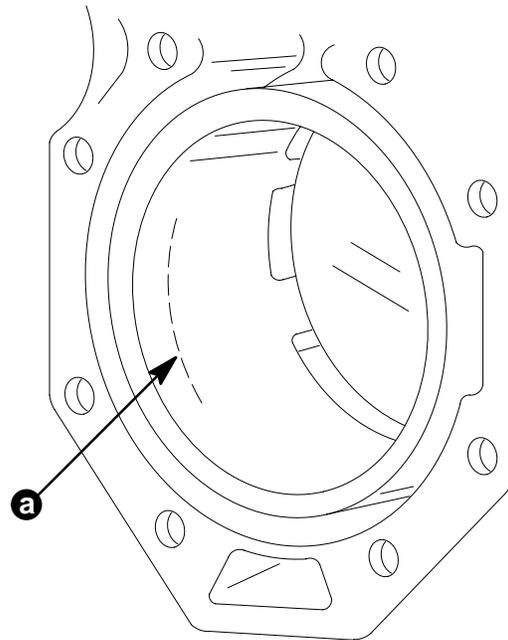
Figure 2. Cylinder Inspection.

- Corrosion/discoloration above ring travel area
- Non-Uniform honing cross hatch
- Minor scratches

- Heavy corrosion or pitting in ring travel area.
- Honing cross hatch worn away.
- Scored Cylinder - deep vertical marks.

a - Limit of Ring Travel.

4. For help or authorization to replace the power-
head if the bore(s) is not acceptable:

5. If the cylinders are acceptable, oil all cylinder
bores and rotate crankshaft.
6. Reassemble cylinder heads with new o-rings and
seals. Oil and install cylinder head bolts. Torque
bolts holding thermostat housing to 30 lb. ft. (40.7
Nm) and rotate an additional 90°. Torque all other
cylinder head bolts to 20 lb. ft. (27.1 Nm) and ro-
tate an additional 90° as outlined in Service
Manual 90-822900 page 4A-36.

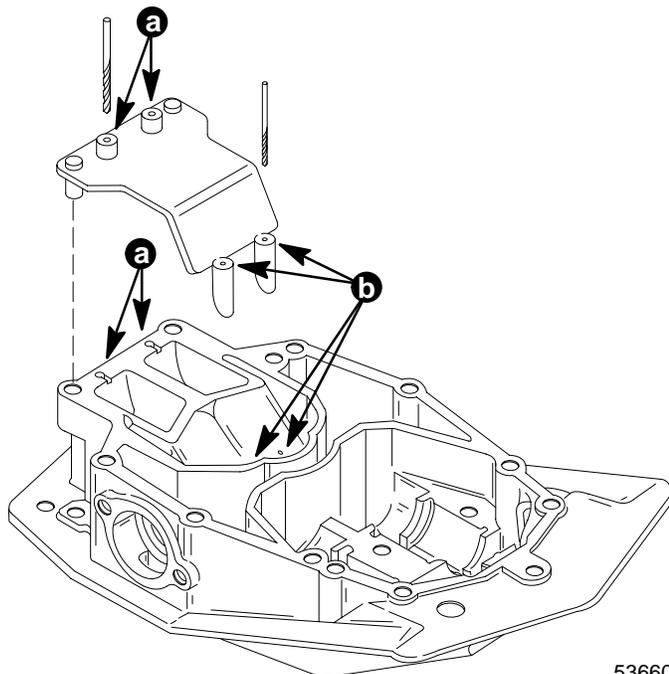
Figure 3. Drilling Fixture.

- a - 3/16 inch (4.8 mm) Diameter Holes 1/8 inch (3.2 mm) Deep.
- b - #39 Drill (2.6 mm) Hole Completely Through Casting Section.

1. Remove powerhead per Service Manual 90-822900 page 4A-7 thru 4A-10.
2. Clean gasket material from powerhead base flange and exhaust adapter plate surface.
3. Clean any corrosion from the powerhead base flange using a small diameter wire wheel on an electric or air tool. Use care not to damage or round-off the gasket surfaces.
4. Paint the powerhead base flange with cold-galvanizing or zinc-rich paint, such as Rust-oleum ZINC-SELE 7785 to prevent corrosion. Apply two light, uniform coats and allow to dry 30 minutes for each coat. Outboards after s/n 0G178948 have a protective coating on the gasket surface.
5. Assemble drill fixture 828809 to the exhaust adapter plate and drill four holes per figure 3.

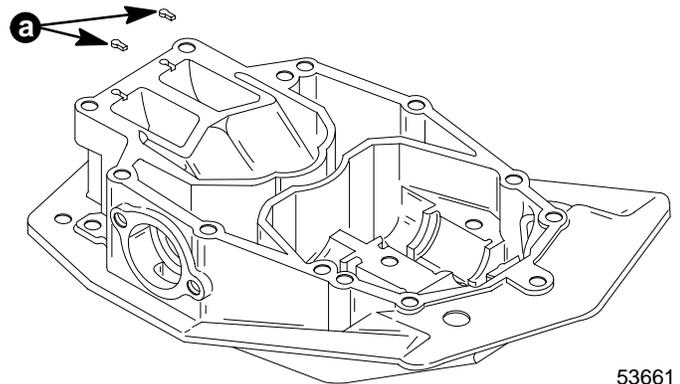
Figure 4. Plug installation.

- a - Plugs (2).

6. Install two p/n 19-828808 plugs into the exhaust adapter plate as shown in figure 4. The top of the plugs must be flush with the gasket surface. It is not necessary to Loctite or seal the plugs in place.

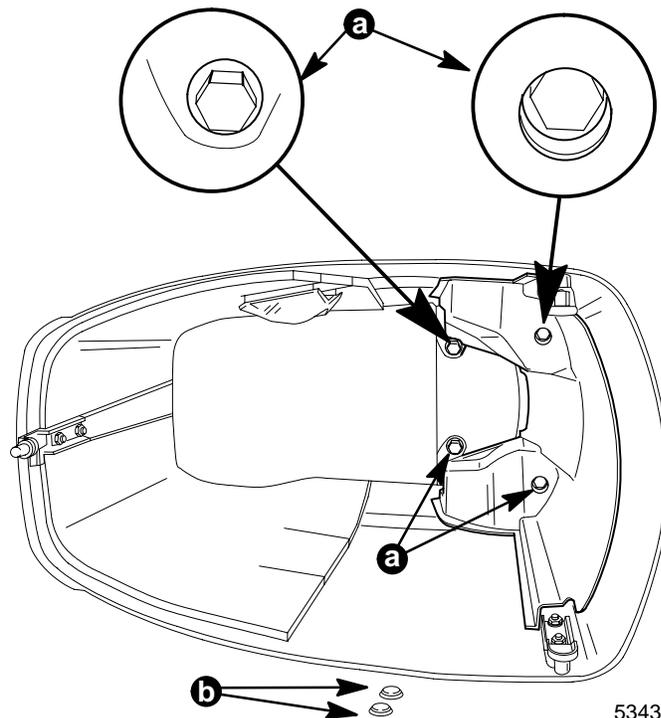
Figure 7. Top Cowl Bottom View.

a - Attaching Screws.
b - Hole Plugs.

1. Remove the top cowl rear air inlet cap by removing the two hole plugs and the four rear cap attaching screws on the inside of the top cowl per figure 7.
