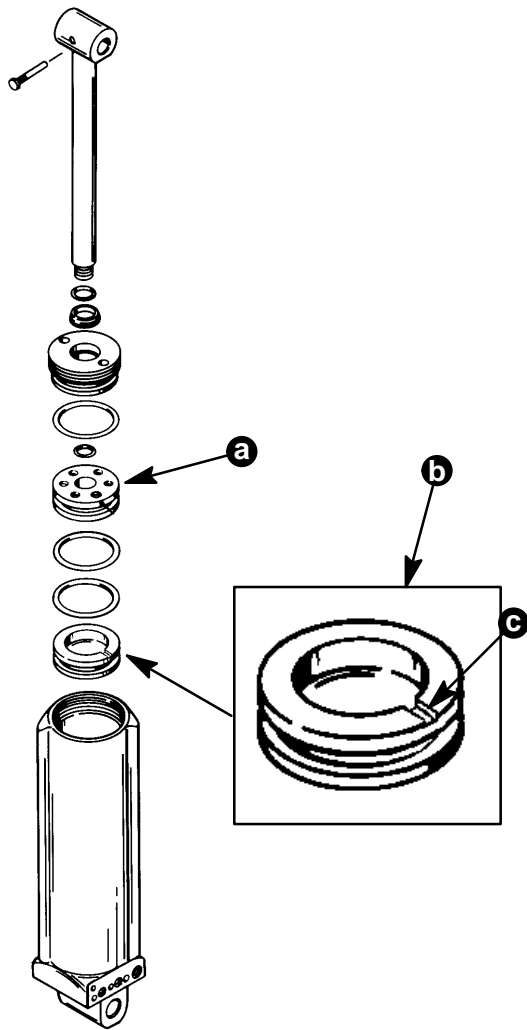
Figure 2. Trim/Tilt Cylinder Assembly.

a - Shock Piston.

b - Memory Piston.

c - .020 – .040 Inch (.5 – 1 mm) Groove.

Disassemble the power trim/tilt ram assembly (refer to the service manual) and remove the memory piston. Cut a small groove .020 – .040 inch (.5 – 1 mm) deep across the top face the memory piston (figure 2). The groove will allow oil passage when the shock piston and memory piston are in contact. The groove can be easily created with a hacksaw or triangular file. Remove all burrs and filings from the memory piston. Reassemble the trim/tilt ram assembly using new O-rings and seals.
