service bulletin

No. 97-17

Cross Pins Missing – Single Ram Trim – 40 thru 125

1998 40 thru 125 hp

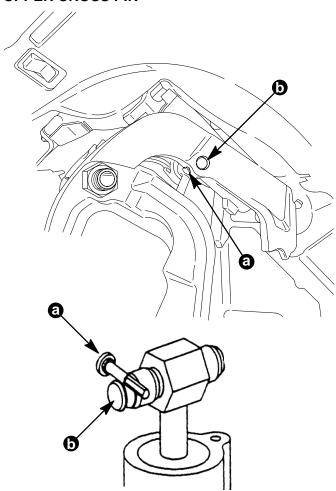
25 (4-STROKE), 50 (4-STROKE) NON-BIGFOOT, AND 30 THRU 50 (2-STROKE) UPPER CROSS PIN

Cross pin (a) MUST be installed through the groove in the pivot pin (b). The head of the cross pin MUST be seated against boss of swivel bracket.

Install missing or incorrectly installed cross pins.

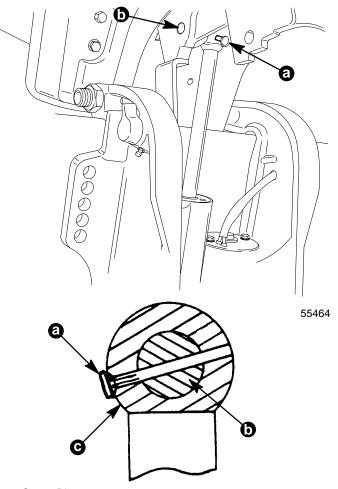
50 (4-STROKE) BIGFOOT AND 60 THRU 125 (2-STROKE) UPPER CROSS PIN

Upper cross pin (a) must be installed through the hole in the pivot pin (b). The head of the cross pin must be seated against the rod eye.

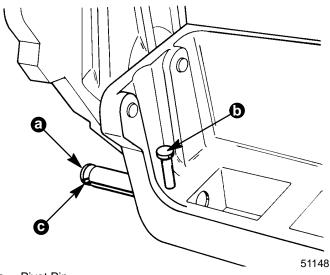
50 (4-STROKE) BIGFOOT AND 60 THRU 125 (2-STROKE) LOWER CROSS PIN

Lower cross pin must be installed through the goove in the pivot pin. The head of the cross pin must be seated against the casting.

The head of the pivot pin is usually flush with the outside of the casting when the cross pin is aligned with the pivot pin groove.
