service bulletin

No. 98-1

Power Trim Piston/Rod Replacement P/N 43397A6

1998 135 - 250 HP

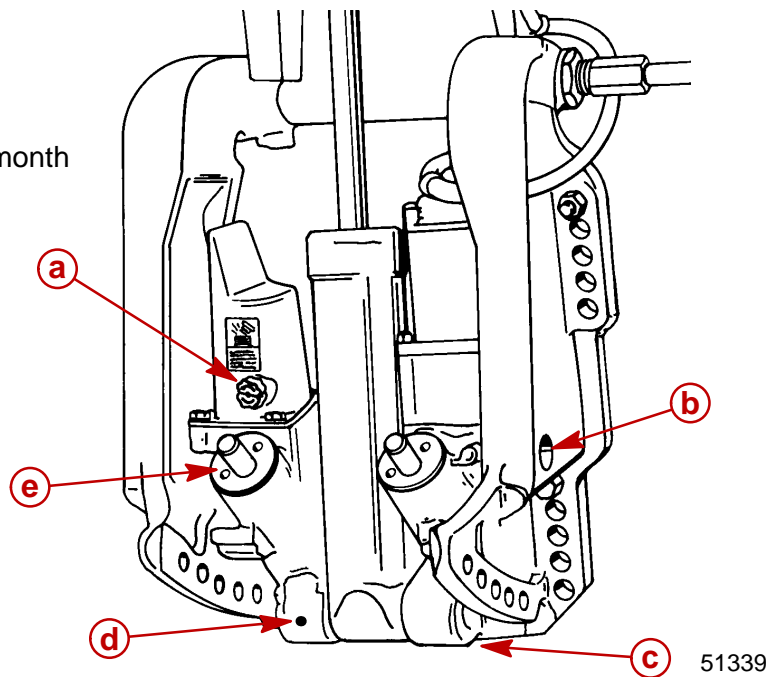
- A white paint dot on the port side of the trim manifold near the tilt cylinder lower cross pin area.
- Engine carton will have a ORANGE dot near the serial number location.

Any engine that **DOES NOT** have the factory rework marking, should have the anode assembly removed from the power trim, to inspect for affected date codes. Affected date codes are 7I02 thru 7K07. Power trims with date codes that are not in the affected range do not require trim piston/rod replacement.

- a - Fill cap
- b - Manual valve
- c - Date code location
- d - Factory rework mark (white dot)
- e - Port trim ram

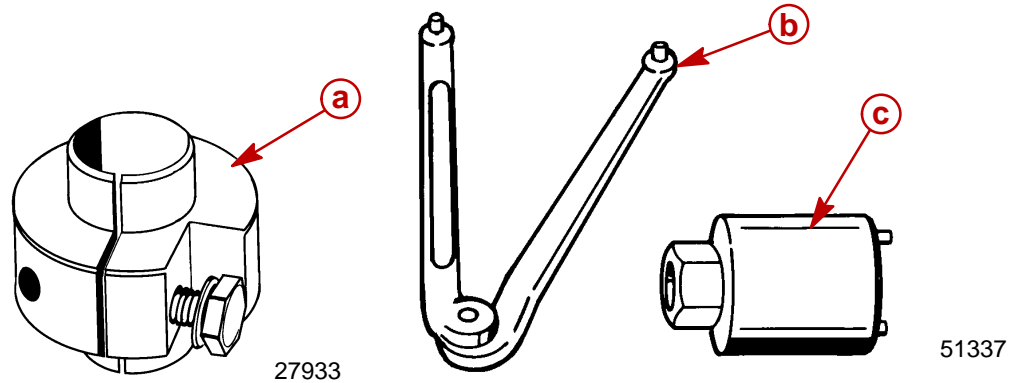
- a - Trim rod removal tool (91-44486A1)
- b - Spanner Wrench (91-74951)
- c - Cap removal tool (91-44487A1)

Loosen the port side trim rod cylinder cap using spanner wrench (91-74951), or cap removal tool (91-44487A1). Before removing , clean any dirt or loose paint chips from around cap area.

Install trim rod removal tool (91-44486A1) and pull trim piston/rod assembly from cylinder.
