ADVISORY
 BULLETIN

No. 99-2

Propeller Whine – 25 Thru 50

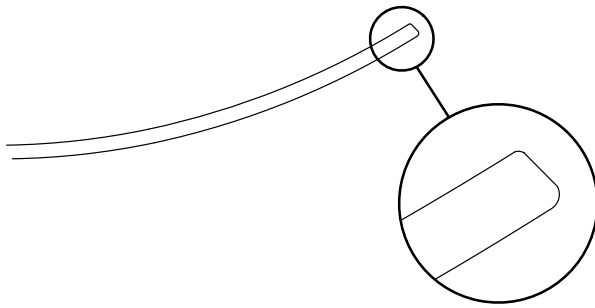
Original Blade Trailing Edge

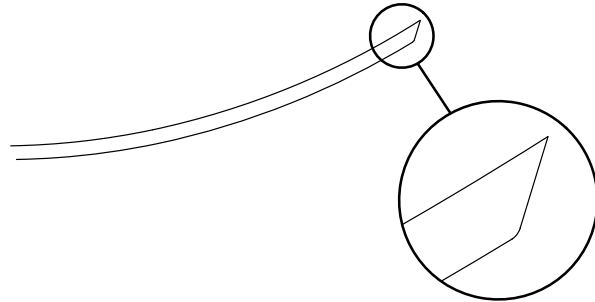
57209

You can identify the new propellers by inspecting the propeller blade trailing edge. The taper begins 3/16 to 1/4 in. (5 to 6 mm) in from the edge and finishes to a fairly sharp point at the very trailing edge of the prop blade.

Chisel Point Trailing Edge

It is recommended to install the new series propeller that has the trailing edge tapered in the form of a chisel point.

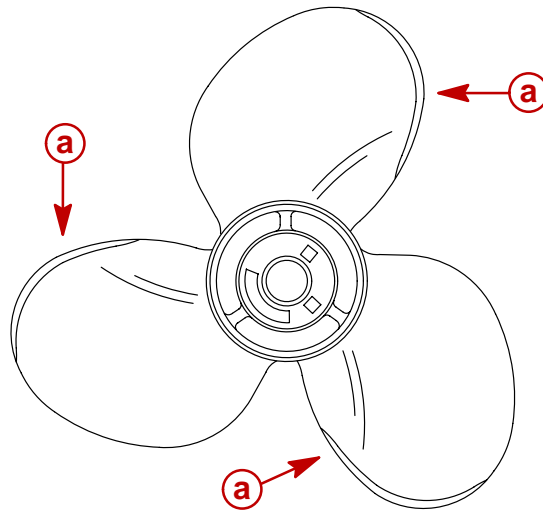
57208

The area of the taper begins approximately 2 in. (50 mm) from the prop hub and extends around to the tip of the blade.

a - Blade Modified Area
Front View

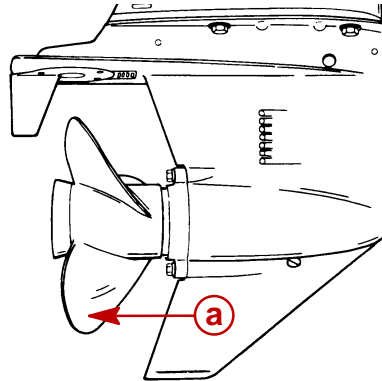
a - Low Pressure Side of Blade
