Service Bulletin

Bulletin No. 2006-09 OEM No. 2006-03

40-60 Horsepower FourStroke Rocker Shaft Screw Torque

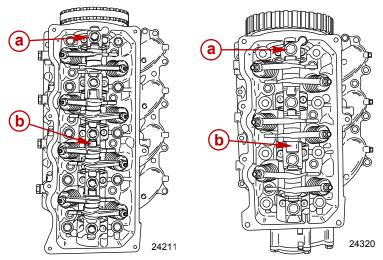
a - Rocker shaft screw (M8 x 23)

b - Rocker arm shaft

- Remove the valve cover. Refer to Section 4A of the service manual for the valve cover removal procedure.
- Remove the top rocker shaft screw. Lubricate the rocker shaft screw threads with 4-Stroke 10W-30 Outboard Oil. Reinstall the rocker shaft screw and tighten the rocker shaft screw to the specified torque.

Description	Nm	lb. in.	lb. ft.
Top rocker shaft screw	9	80

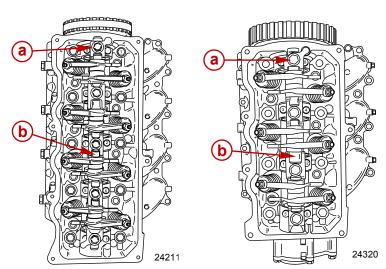
a - Rocker shaft screw M8 x 23

1. Remove the rocker shaft screws securing the rocker shaft to the cylinder head **NOTE**: The four cylinder engine has 5 rocker shaft screws. The three cylinder head has 4 rocker shaft screws.

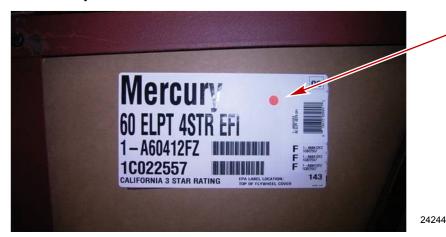
Orange dot on the serial mat

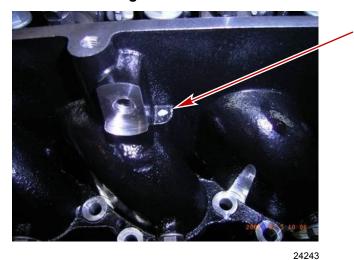
White dot on the cylinder head
