Service Bulletin

Bulletin No. 2006- 16 OEM No. 2006-07

Corroded Key Switch due to Incorrect Installation

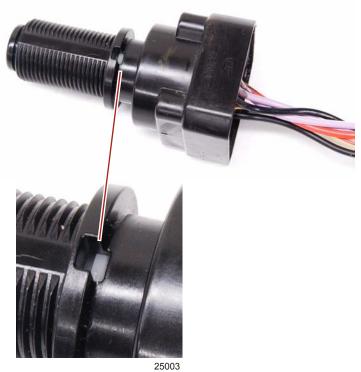
25004

White plastic tumbler viewed through drain hole

Install the switch with the drain hole facing down. The drain hole can be identified on either the 3 or 4-position key switch by rotating the key and viewing the white inner key tumbler assembly moving. The opposite side is only an index notch and not a drain hole.

Later versions of the key switch assemblies will have a yellow paint dot placed next to the drain hole to aid in correct installation.
