# Official Recall Notification U.S. Federal Boat Safety Act - Throttle Sticking on 25/30 EFI FourStroke Outboard Product

Models Covered	Serial Number Or Year
Mercury/Mariner 25/30 EFI FourStroke Outboard Tiller Handle Models	0R125005 through 0R145228

**NOTE:** This product recall only pertains to Tiller Handle model engines. Remote control versions are not affected.

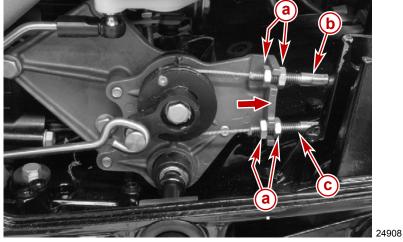
- a Jam nuts
- **b** Upper shift/throttle cable (reverse when pulled in direction of arrow)
- c Lower shift/throttle cable (forward when pulled in direction of arrow)

15. Remove the two shift/throttle cables from the throttle drum by loosening the jam nuts.

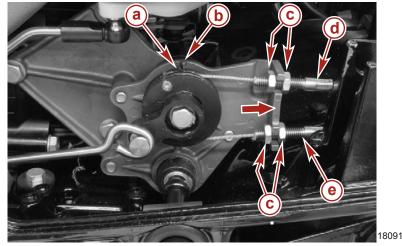
**NOTE:** The throttle drum assembly must have the alignment marks lined up during the installation of the throttle only assembly onto the engine. This ensures the linkage is in the correct orientation for the engine when in the neutral position.

- a Match mark on shift/throttle pulley
- b Match mark on gear plate
- c Jam nuts
- d Upper shift/throttle cable (reverse when pulled in direction of arrow)
- e Lower shift/throttle cable (forward when pulled in direction of arrow)
- 22. Verify that the shift actuator pin is installed and held in place during the installation of the throttle only assembly.

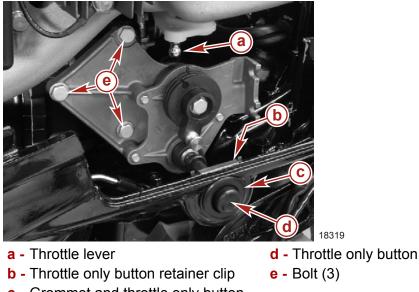
**c** - Grommet and throttle only button retainer

24. Install the grommet, throttle only button, and retainer.

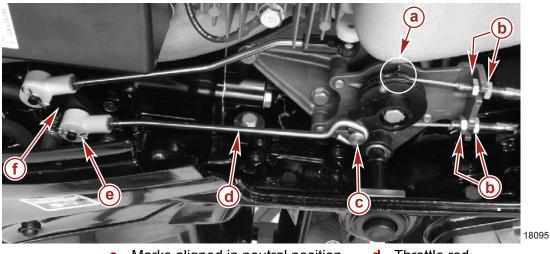
- a Marks aligned in neutral position
- **b** Control cable jam nuts
- **c** Throttle opener

- d Throttle rod
- e Cotter pin and washer
- f Throttle arm
- 27. Install and secure the ECM onto the engine with two bolts. Torque the bolts to specification.

- 25. Install the shift/throttle cables onto the throttle drum. Adjustment of these cables will take place later in the bulletin.
- 26. Install throttle rods onto throttle arm using the old washers and the new cotter keys provided.

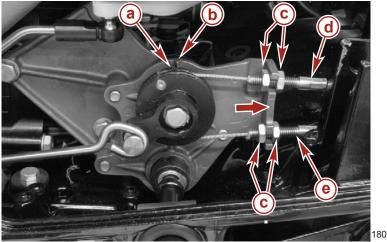
- a Match mark on shift/throttle pulley
- **b** Match mark on gear plate
- c Jam nuts
- d Upper shift/throttle cable (reverse when pulled in direction of arrow)
- e Lower shift/throttle cable (forward when pulled in direction of arrow)
- Rotate the tiller throttle handle from forward wide open throttle to reverse wide C. open throttle. Verify that the match marks are in alignment. Readjust if necessary.

- Rotate the tiller handle to the neutral position. a.
- Adjust the cable lengths using jam nuts to bring the match marks into alignment. b.
  - i. Make adjustment to the lower cable first.
  - ii. Remove the slack in the upper cable by adjusting the upper jam nuts. Do not overtighten the jam nuts.

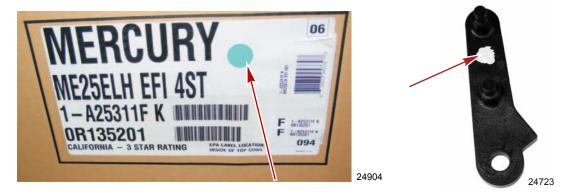
Engines reworked at the factory will have a blue dot on the serial matte, and a white dot on the throttle arm. Engines reworked in the field will have a white paint mark on the throttle arm.
