ADVISORY
 BULLETIN

No. 2000-06

Wire Harness Shunt Resistor – 25, 30/40/40 Bigfoot (4-Stroke)

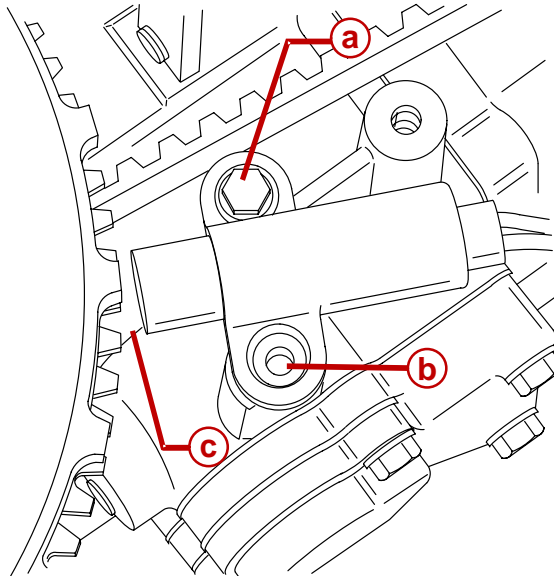
58140

If the engine exhibits a “miss” in the rpm range from 2000 rpm to wide open throttle (WOT), a simple test can be performed to determine if the wire harness shunt resistor will remedy that particular problem. Remove one of the crank position sensor mounting bolts. Loosen the remaining bolt and reposition the sensor to achieve an approximate flywheel to crank sensor air gap of 0.125 inch (3.18 mm). Retighten the one bolt to retain the sensor position.

- a** - Mounting Bolt
- b** - Mounting Bolt Removed
- c** - 0.125 inch (3.18 mm) Gap

Rerun the engine and determine if the miss is still present.

If the miss is still present: The installation of the wire harness shunt resistor will not remedy the situation. It will be necessary to troubleshoot the ignition and fuel system.

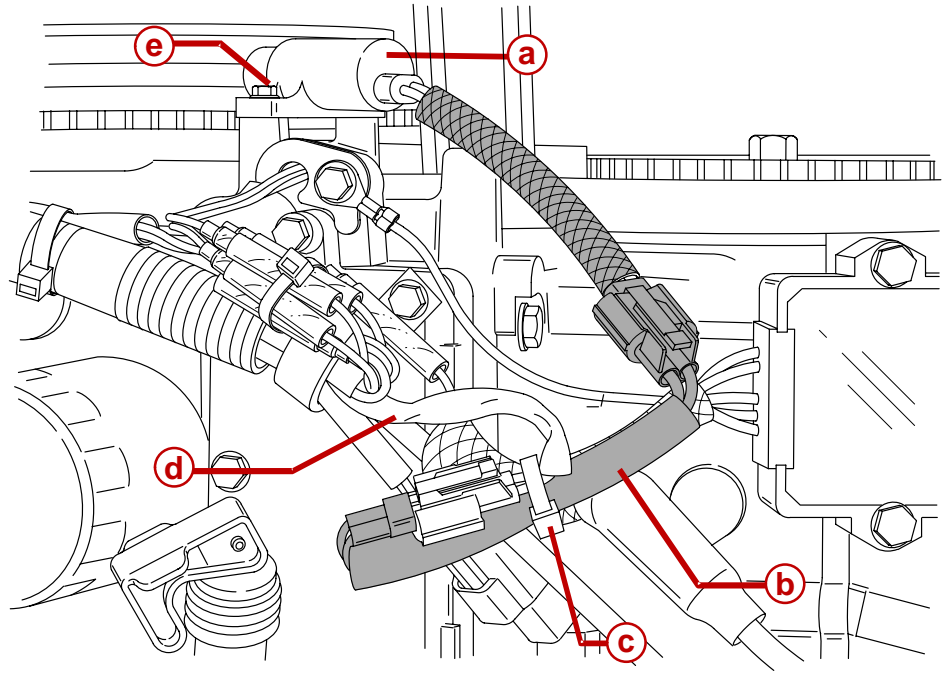
58137

Some engines that exhibit a mid to high speed mis-fire may require the installation of a wire harness shunt resistor. The mis-fire is caused by a combination of ignition components that prematurely activate the rev limiter function. Due to the fact that a specific combination of components is required, not every engine that exhibits the mis-fire will require the installation of the shunt resistor. It is important to inspect basic ignition and fuel related components that could cause this similar characteristic.

- a** - Crank Position Sensor
- b** - Wire Harness Shunt Resistor
- c** - Sta-Strap
- d** - Engine Wire Harness
- e** - Mounting Bolt - Torque 45 lb. in. (5.1 N·m)

If the mis-fire is not present: Install the wire harness shunt resistor at the crank position sensor terminal. Install a sta-strap to retain the wire harness.

Reposition the crank position sensor, install the bolt removed, and tighten the mounting bolts. Crank position sensor mounting bolt torque - 45 lb. in. (5.1 N·m).
