ADVISORY
 BULLETIN

No. 2000-07

Air Compressor End Cap Oil Leak

MERCURY/MARINER
200/225 HP, 3.0 LITRE OPTIMAX
S/N 0T136400 Thru 0T161961

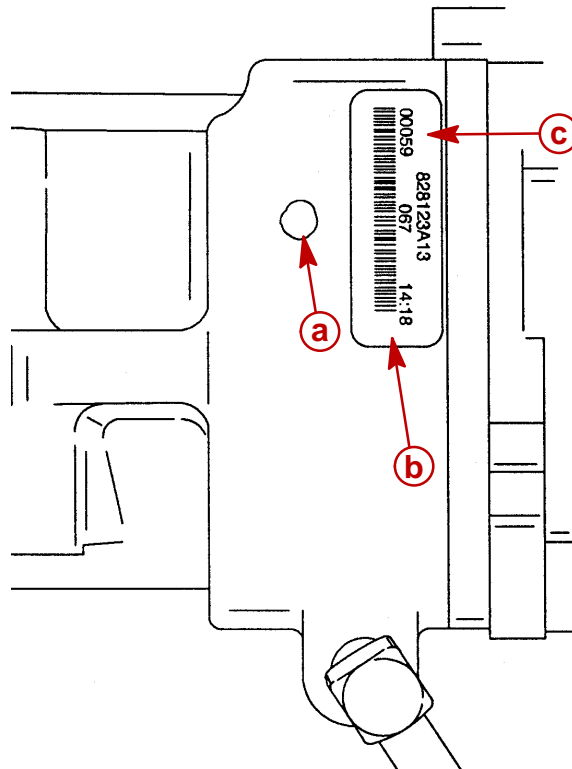
ENGINE OUT OF CARTON: Check the date code on the air compressor bar code label. If the date code is between 00055 and 00073, look for a WHITE paint dot next to the bar code label. A WHITE paint dot indicates that compressor has been reworked at the factory, and no further action is required.

- a** - WHITE Paint Dot
- b** - Bar Code Label
- c** - Date Code

If the compressor is within the above listed date code, and does NOT have a WHITE dot next to the compressor bar code label, replace the air compressor end cap assembly with **P/N 1173-828131A5**. The new assembly includes the end cap, crankshaft, bearings, spacer, pulley flange, seals, and O-rings.

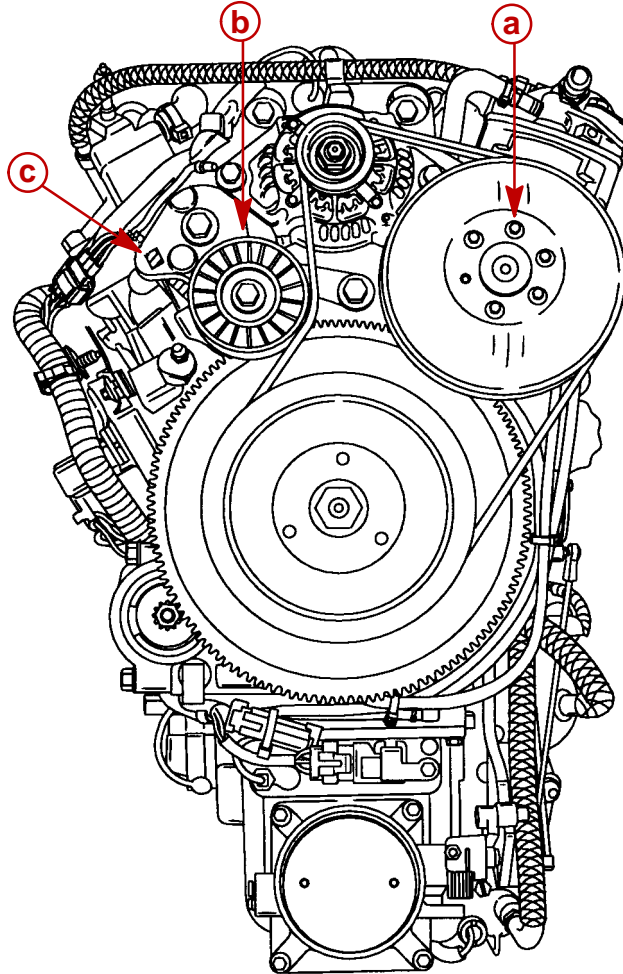
57784

- a** - Pulley Retaining Bolts (5)
- b** - Tensioner
- c** - 3/8 inch (9.5 mm) Square Drive

- Remove flywheel cover.
- Use 3/8-inch (9.5 mm) drive on belt tensioner arm to relieve belt tension, and remove belt.
- Remove the 5 bolts that retain the pulley to the pulley flange.

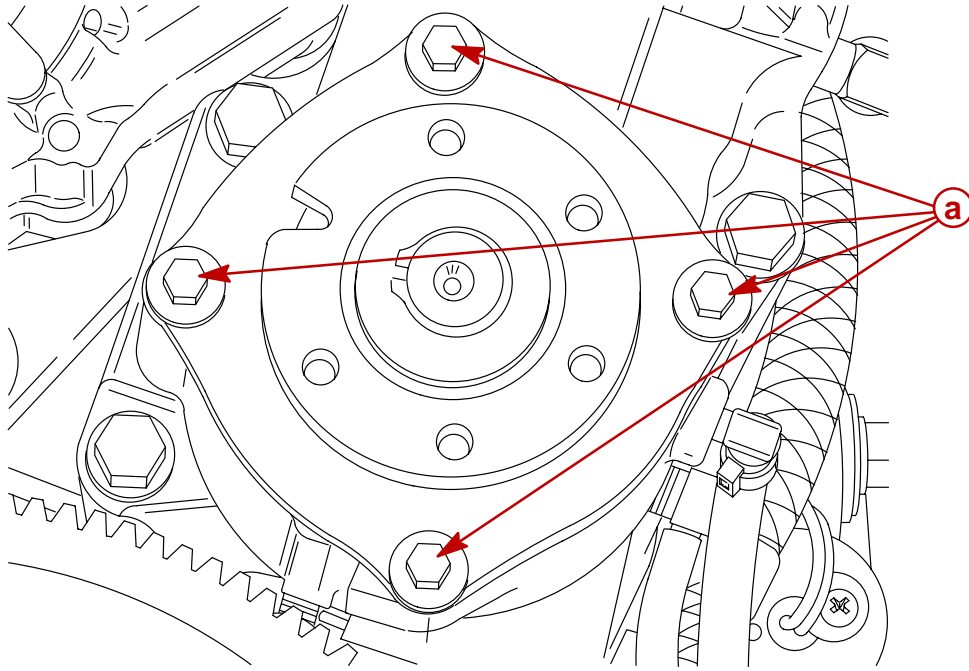
57809

a - End Cap Retaining Bolts (4)

- Remove the 4 bolts that retain the end cap to the compressor body.

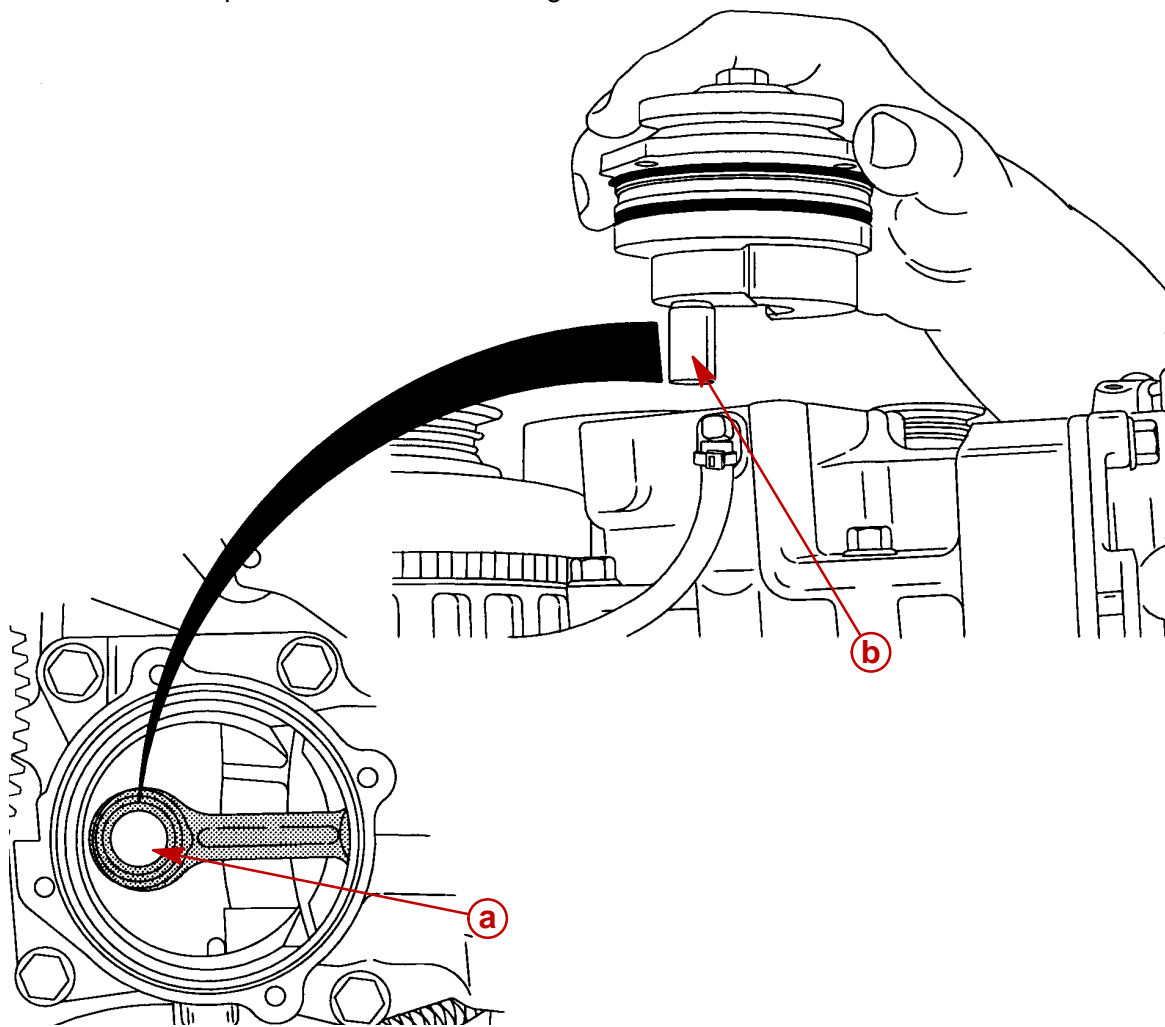
a - Connecting Rod Open End
b - Crankshaft Connecting Rod Journal

- Lubricate end cap O-ring and O-ring contact area in compressor body with two cycle oil.
- Slide the new end cap assembly into the compressor body, keeping the connecting rod journal lined up with the open end of the connecting rod, until the crankshaft just enters the open end of the connecting rod.
