ADVISORY

BULLETIN

No. 2000-08

Oil Control – 25, 30/40, 40/45/50 (4-Stroke)

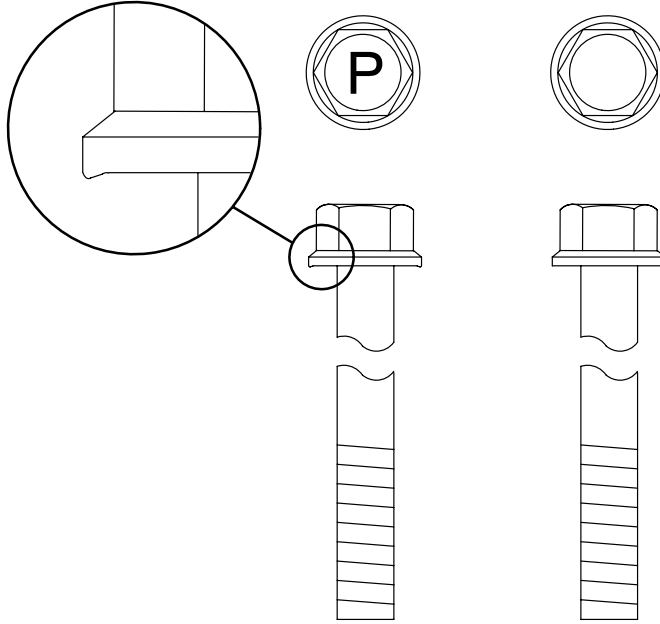
58131

Previous to serial number 0T117737, powerhead bolts may have a small raised edge on the underside of the washer/head. As the raised edge cuts into the aluminum adaptor plate during normal running, the clamp load is reduced. The reduced clamp load may cause the powerhead gasket or the adaptor plate gasket to leak. If an oil leak is present, inspect and replace, if necessary, the bolts that have a raised edge under the washer/head. Reassemble with a new powerhead gasket and adaptor plate gasket. Powerhead bolts without raised edges were installed on the production line beginning with serial number 0T117737.

Powerhead Bolt changed:

USA S/N 0T117737 (January 18, 2000)

Possible
Raised Edge

Flat Surface

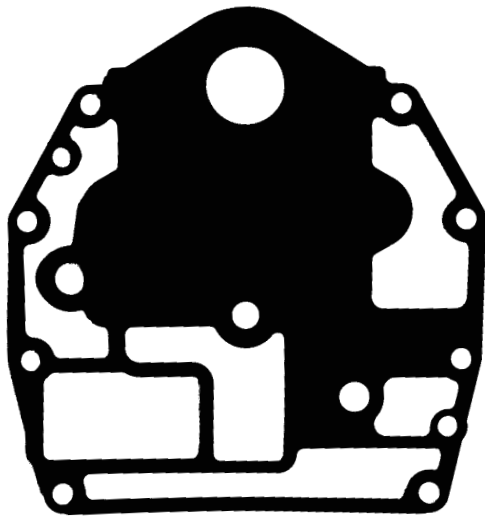
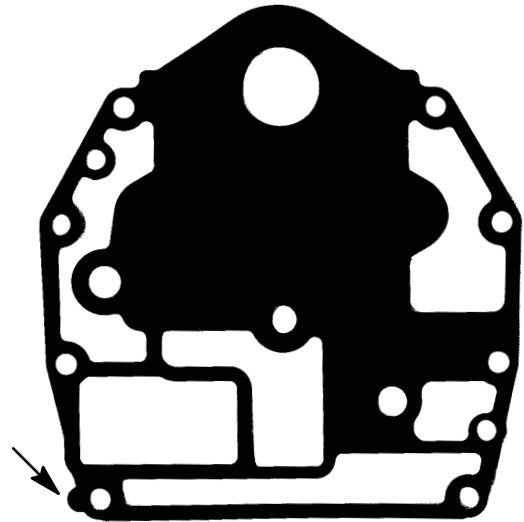
25 Powerhead Gasket
27-825231--1

It is important to install the proper powerhead gasket. The part numbers and design are very similar for the 25 and the 30/40 product.

Powerhead Bolt Torque 28 lbs. ft. (38 N·m)

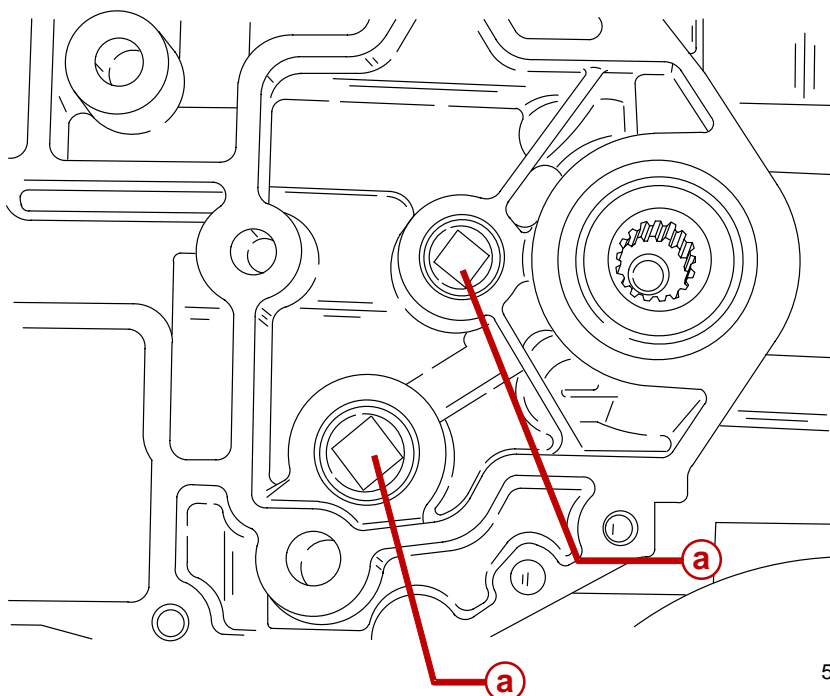
58265

Assembly improved the sealing of the oil passage plugs by adding a pre-applied Loctite to the plug. Some units previous to serial number 0T097570 may leak. If an oil leak occurs on the bottom side of the powerhead, remove the powerhead and inspect for leakage at the oil passage plugs. If they are leaking, remove, clean, and reseal the plugs with Loctite 567 PST Pipe Sealant part number 92-809822. DO NOT use Teflon tape. The tape may tear during assembly and plug an internal oil passage. Install the plug until it is flush with the surface. Installing the plug to an increased depth may restrict the oil flow inside the oil passage.

Sealant Changed at:

USA S/N 0T097570 (December 07, 1999)

a - Oil Passage Plugs
