ADVISORY
 BULLETIN

No. 2000-01

Official Notification Federal Boat Safety Act Steering Link Rod Attaching Bolt V-6

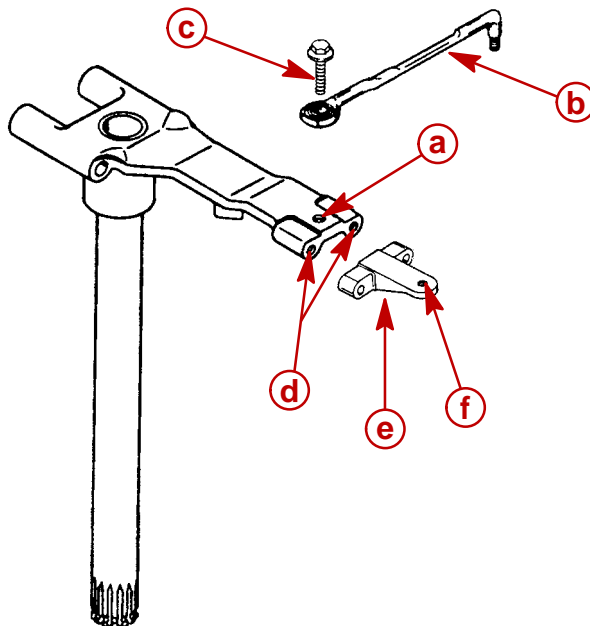
The steering arm top attaching bolt may be at risk for failure. In order to avoid this risk a replacement bolt must be installed. See the "Parts Required" section below in order to identify the correct replacement bolt.

- a** - Steering arm top attaching hole, if used, bolt **MUST** be replaced
- b** - Steering link rod
- c** - Attaching bolt if connected to hole (a) **MUST** be replaced
- d** - Front attaching holes, if used, bolts **DO NOT** require replacement
- e** - Extension bracket
- f** - Attaching hole in extension bracket, if used, bolt **DOES NOT** require replacement

Our records indicate that you are the owner of a Mercury Marine outboard included in a recall. Due to a manufacturing error, the steering arm top attaching bolt hole, may be incorrectly drilled at an angle. Under extreme steering torque conditions, this may cause extra strain on the link rod attaching bolt, which could result in bolt failure (steering disconnect).

Affected engines in the above serial number range using attaching hole **(a)** should have the link rod to steering arm attaching bolt replaced. Engines using OEM/after market steering systems may require various length bolts. Choose the correct bolt length from the following chart. Since the replacement bolts are not offered with shoulders, engines using Teleflex Clevis Kit P/N SA27314P with shoulder bolt, must replace the clevis with Quicksilver Clevis Kit P/N 70599A5, and also use the replacement bolt from the following chart.
