No. 2001-04

Tachometer Signal - 75/90 Four Stroke

2000 & 2001 Model Year 75/90 Four Stroke

Serial Number 0G960500 thru 0T320116

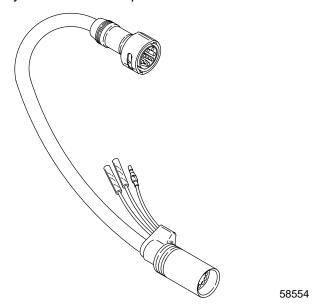
Remote Control Electrical Harness Adaptor 84-858740T2

A limited number of tachometer designs may not read accurately at high engine speeds. These tachometers may cause the reading to "flutter" and/or drop 500 rpm when the outboard is operated at approximately 4000 rpm. Above 4000 rpm the tachometer readings may remain up to 500 rpm lower than actual engine speed.

The result is the outboard may have a propeller pitch installed that is too low if the installers were referring to an inaccurate in-dash tachometer reading. This inaccurate tachometer reading combined with a propeller pitch that is too low may cause the engine to activate the rev limiter without the knowledge of the operator.

75/90 four stroke products beginning with serial number 0T320117 have a new remote control electrical harness adaptor 84-858740T2 installed at the factory. This new harness adaptor will provide an accurate tachometer reading with all tachometers.

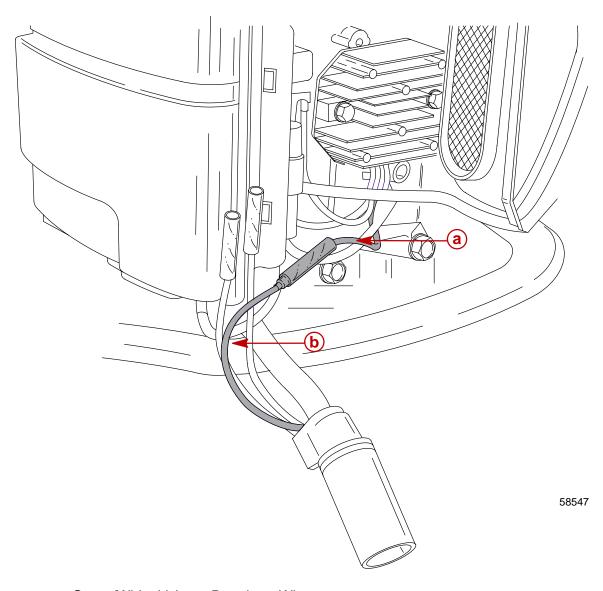
Engine Harness Adaptor Installed

- a Green/White Voltage Regulator Wire
- **b** Gray Wire

In-dash tachometers that exhibit the "flutter" and low rpm reading on the models listed in this advisory can be corrected. Remove the existing remote control electrical harness adaptor and install a new harness adapter 84-858740T2. This new harness adaptor has an additional gray wire exiting the connector with the two power trim wires. The additional gray wire connects to the voltage regulator green/white wire. An installation instruction sheet is provided with the new harness adaptor. The new harness adaptor will supersede the previous 84-858740T1 harness adaptor.
