Service Bulletin

OEM No. 2004-10

Official Recall Notification United States Federal Boat Safety Act 8/9.9 2005 Model Year FourStroke Tiller Tube Replacement

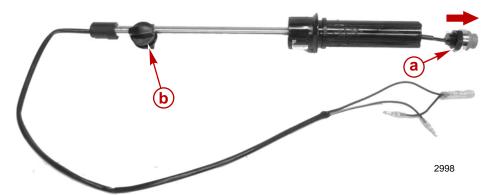
- a Stop button/wire assembly
- **b** Friction control knob and clamp
- 13. Remove tiller tube from handle.

14. Install new tiller tube (part number 803998003) and follow these directions in reverse order for installation.
