Service Bulletin

Bulletin No. 2005-08 OEM No. 2005-07

Mercury 4000 Series Panel Mount Control - Pistol Grip

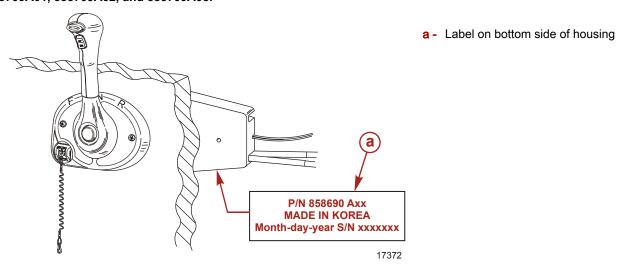
- Have been installed in boats with the last four digits of the Hull Identification Numbers (HIN) between J000 (October, 2000) through F505 (June, 2005) are affected.
- 2. Have remote controls with dates of manufacture that are on the labels located as shown in the figure below between October, 2000 and May, 2005.

Mercury Marine has identified a potential problem with the manufacturing of the 4000 series pistol grip panel mount remote controls. The amount of force required to move the shift handle out of the "NEUTRAL" detent lock position without depressing the release button, in a very small percentage of these controls, was found to be below specification.

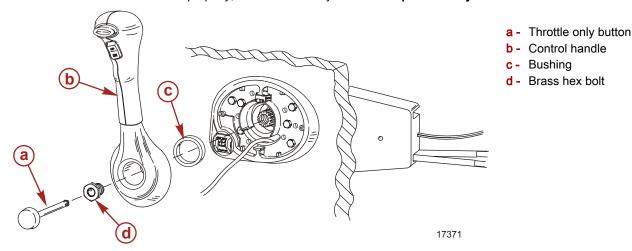
- e. If the handle lock functions properly, no further action is required.
- 4. If excessive free play is felt, it indicates that either the bolt that secures the handle to the control may not be fully seated or the bushing between the handle and bezel is missing. Either condition may allow the control handle to shift into gear without depressing the neutral release button while using minimal force. The excessive free play condition must be corrected before proceeding with any testing as described previously.

- a. Remove the throttle only button by:
 - Placing the control handle in the "NEUTRAL" position.
 - · Push in the throttle only button.
 - Advance the handle forward to the first detent felt.

- · Release the throttle only button and carefully pry it out. This exposes the hex head bolt in the bore of the handle.
 - b. Loosen the bolt approximately 1/4 turn. Then retighten the bolt and torque to specification. This should rectify the free play condition.

- c. If the free play still exists, remove the bolt. Remove the handle from the control and check to ensure the handle bushing is installed. If the handle bushing is not installed, purchase a new bushing (23-859016). Install the bushing and reinstall handle.
