Service Bulletin

Bulletin No. 2007-25R2

PCM Failures Due to Failed Ignition Coil

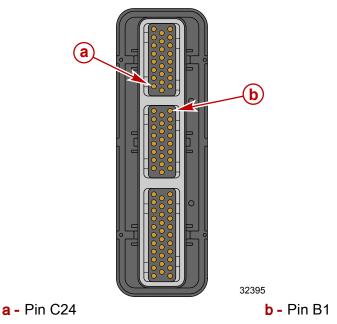
The PCM can fail due to a faulty ignition coil. The failures are due to a short between the 12 volt supply to the ignition coil and the electronic spark trigger (EST) low or ground circuit of the ignition coil. A short of this type would supply 12 volts directly to the EST ground circuit in the PCM, failing that circuit and resulting in a no spark condition on all cylinders.

To confirm that the EST ground circuit in the PCM has been damaged, a resistance check between pins B1 and C24 of the PCM connectors should indicate an open circuit or high resistance value if it has failed. A good PCM will measure as a short or very low resistance (normal is 0.5 ohm or less).

If a PCM is diagnosed as the reason for a no spark condition, test all ignition coils following the ohm/pinout test shown following. Replace any defective coils prior to replacing the PCM.

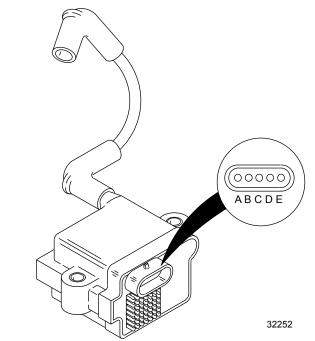
Ignition coil harness service replacement connector P/N 854839T02 can be used to help test the coils by providing better access to the coils connector pins.
