Service Bulletin

Bulletin No. 2017-05R1

2.5L and 3.0L Air Compressor Reed Failure

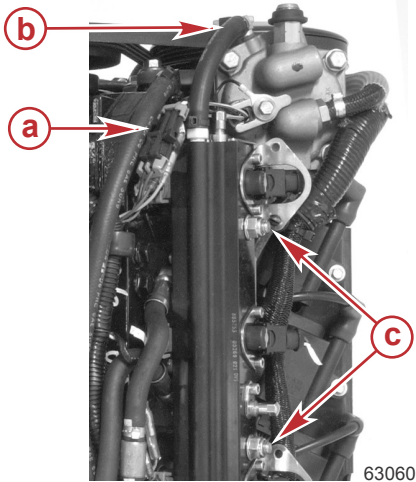
- a - Cylinder head temperature sensor harness connector
- b - Compressor water inlet hose
- c - Fuel rail mounting nuts (2)

3. Remove the two fuel rail mounting nuts.

4. Without removing the lower cowl, position the fuel rail out of the way, and complete the reed plate assembly replacement. Before putting the engine back into service, be certain to reconnect all items and tighten the fuel rail mounting nuts to the specified torque.

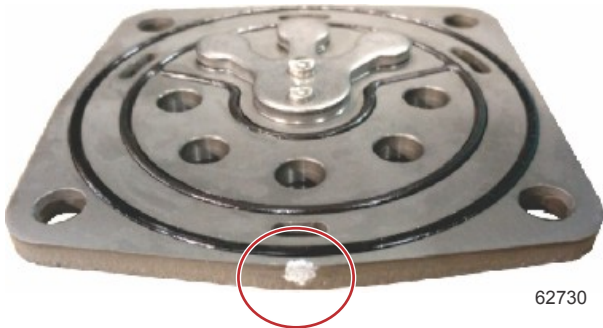
Reed plate assembly edge marked with a white dot

- To indicate that the rework procedure has been completed, mark the top edge of the replacement reed plate assembly with a white dot.
