# MERCUISER SERVICE BULLETIN

Number: 67-866-27

Date: 12/28/66

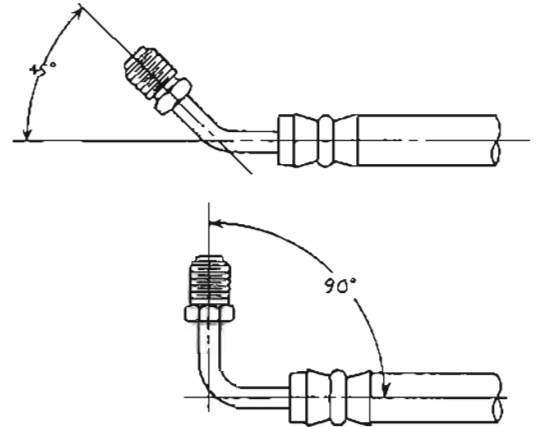
Figure 1. Hose Angles

When hydraulic pump mounting bracket B-46306A1 is required on MerCruiser 120 or 160 Stern Drive Units with Power Trim, it will be necessary to reposition the hydraulic hoses. Remove hose clamp from lower left hand corner of inner transom plate and rework the end of the hose from a 90° angle to a 45° angle. (Figure 1) Current production MerCruiser 120 and 160 units have longer (22" [56cm]) hoses installed.
