MERCUISER SERVICE BULLETIN

Section: XII (Service
Bulletins)
Number: B 63-12
Date : 8/19/63

- A. Engine Repair Stand for MerCruiser I & II Gasoline Engines
- B. Engine Coupling Assembly Lubrication
- C. Special Fuel Tanks - Cautions

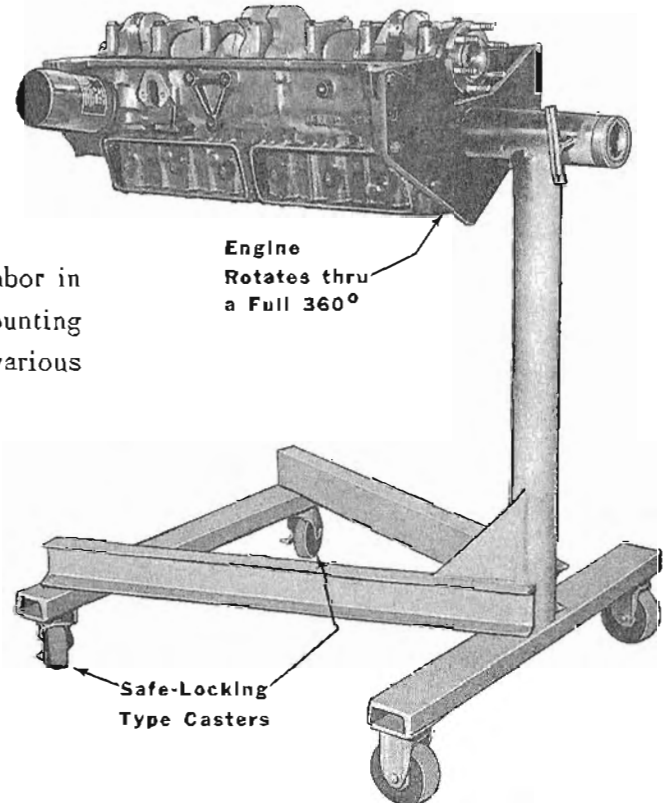
91-35135

The answer for safe, easy handling of MerCruiser 4-cycle engines during repair and overhaul . . . very sturdy and completely mobile . . . saves time and labor in repairing and handling of engines. Engine mounting bracket permits engine to be rotated 360° for various service operations. See figure on right.

Engine Repair Stand
