INCORRECT LOCATION of SHIFT CABLE ANCHOR STUDS on MCM 888 and 233

(Attach Bulletin Reference Sticker to P. 2B-8 of Your Service Manual.)

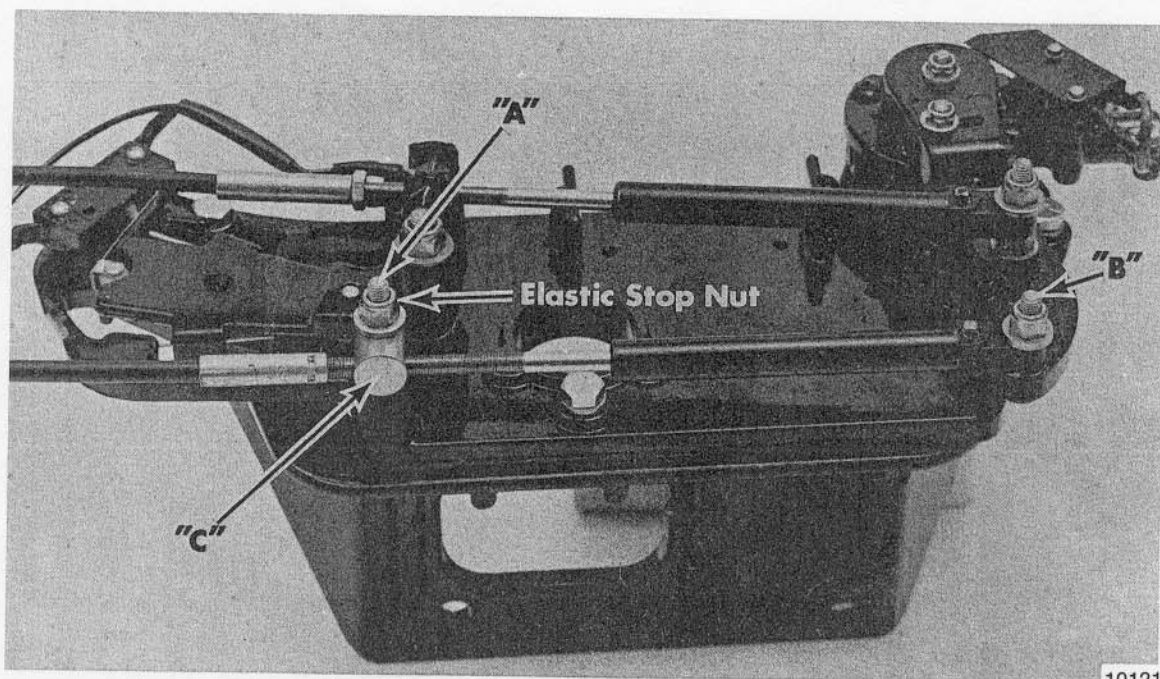
On some MCM 888 and 233 transom plate assemblies, shift cable anchor studs "A" and "B", shown in Figure 1, were installed in the wrong location on the shift bracket assembly, with the result that stud "A" is too short. It will not extend thru the elastic stop nut (shown) when shift cable brass barrel "C" is installed. At least four (4) threads of stud must be exposed through nut. Studs "A" and "B" MUST BE reversed, or stud "A" only must be replaced, to ensure correct stud extension thru the elastic stop nut.

Figure 1. Shift Bracket Assembly (Removed from Engine for Clarity)

A stud remover or vise grip pliers and heat will be required to remove studs, as studs are secured in place with Loctite.

If studs are damaged during removal, or if replacement studs are desired, order part numbers listed below. Submit warranty claim for parts and 0.2 hours labor for each unit corrected. Serial numbers of drive units and date code of the transom plate must be listed on the claim.

Stud "A": Part No. 16-47360

Stud "B": Part No. 16-63081
