- A. Transom Cutout and Steering Lever Interference
- B. Bell Housing to Drive Shaft Housing Studs

A. TRANSCOM CUTOUT and STEERING LEVER INTERFERENCE

B. BELL HOUSING to DRIVE SHAFT HOUSING STUDS

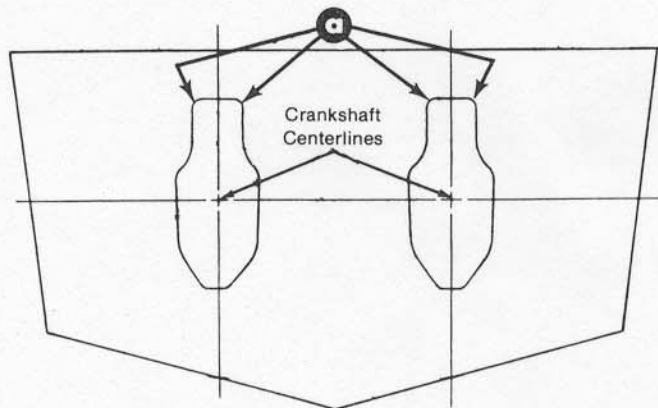
Figure 1. Typical Transom Cutout

The top corners of the transom cutout on all MerCruiser Stern Drives (Figures 1 and 2) must be cut at angle specified in appropriate model "Stern Drive Installation Manual". If cut at other than specified angle, steering lever can contact transom and limit steering and/or cause hard steering.

If Power Steering is used (because drive unit travel stops before Power Steering travel stops), pump lugging in a tight turn possibly could cause damage to Power Steering system and render Power Steering inoperable.

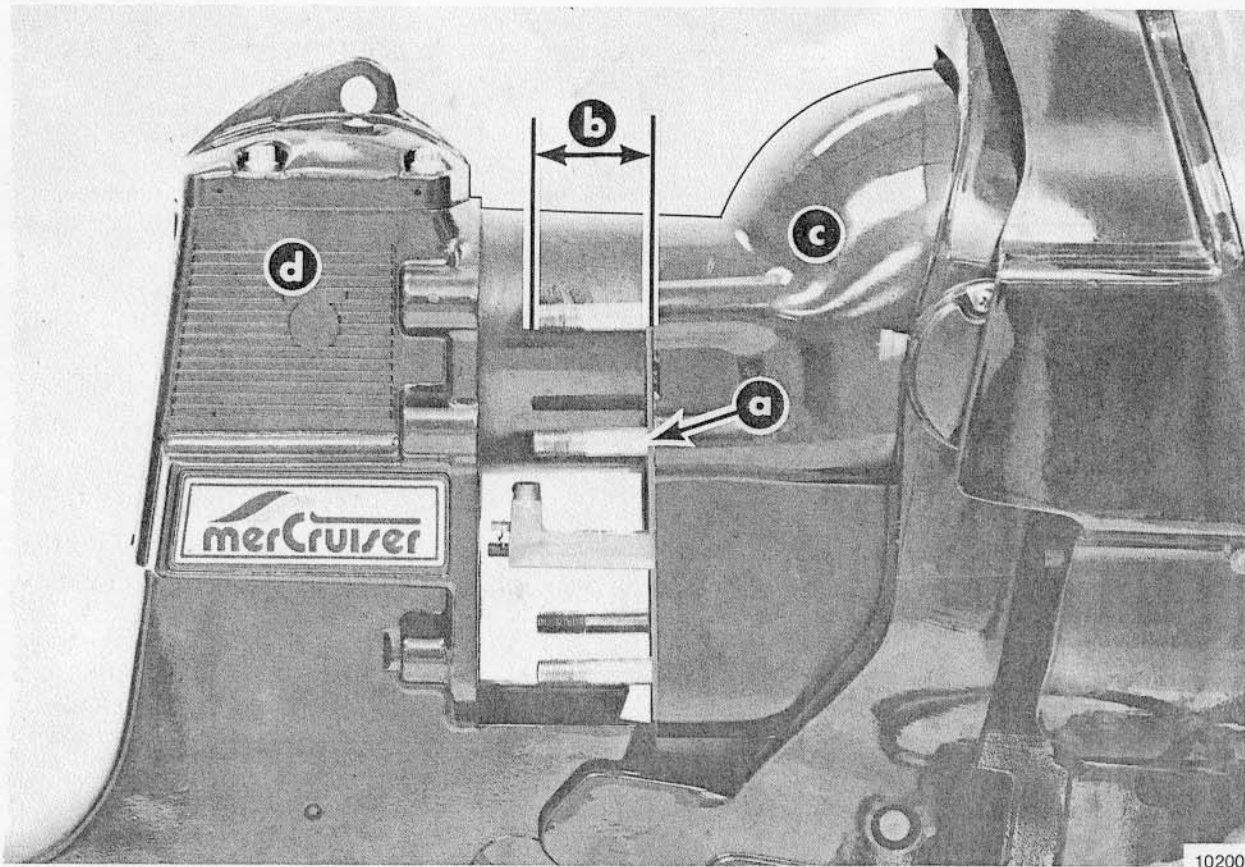
Figure 3. Bell Housing Studs

There may be some MerCruiser I drive transom assemblies in the field that have short bell housing to drive shaft housing studs. (Figure 3) Studs must protrude from bell housing a minimum of 1-13/16" (46mm) when fully installed, as shown in Figure 3.

Replace short studs with stud C-16-59579. Send short studs along with warranty claim to your local Mercury Branch or Distributor.
