NUMBER: 81-2

DATE: 3/6/81

- A. Insufficient Engine Intake Air
- B. MCM 470-485 Torque Specification Change
- C. Quadrajets Carburetor Rough Idle

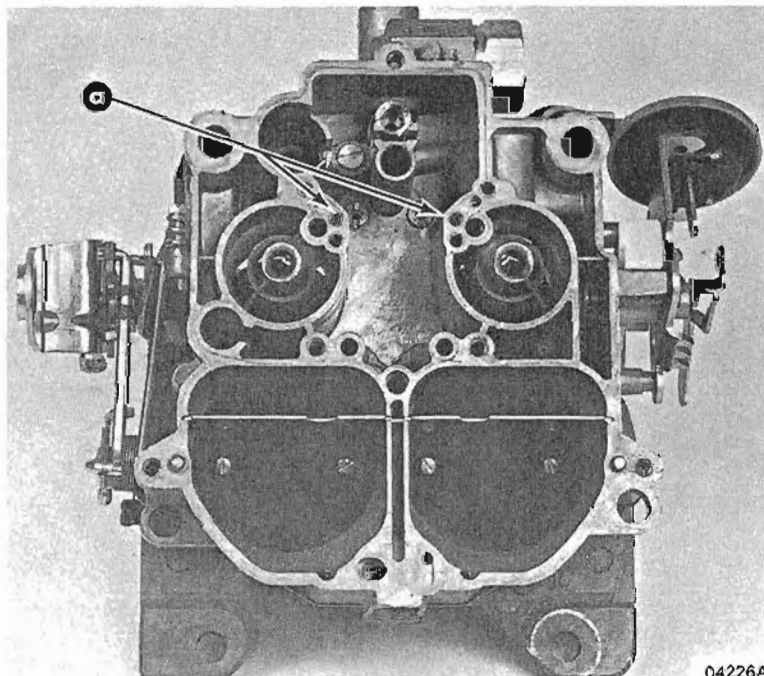
**Figure 1. Air Vent Tube Location
in Quadrajets Carburetor**

Our Service Department checked several Quadrajets Carburetors (MerCruiser 228-260) that were sent in for warranty. The complaint was engines would not idle smoothly and could not be adjusted with the idle adjustment screws. It was determined, the idle air vent tubes were plugged. To correct this problem, run a fine wire through the vent tubes. (See Figure 1 for location.) Smaller wire than the opening at the bottom of the tube must be used. The vent tubes are tapered down smaller at the bottom.

a - Idle Air Vent Tubes
