STERN DRIVES/INBOARD ENGINES

# service bulletin

NUMBER: 81-23  
DATE: 9/14/81

**Subject: II-TR TRANSMISSION OIL COOLER DRAINING  
and WINTERIZING**

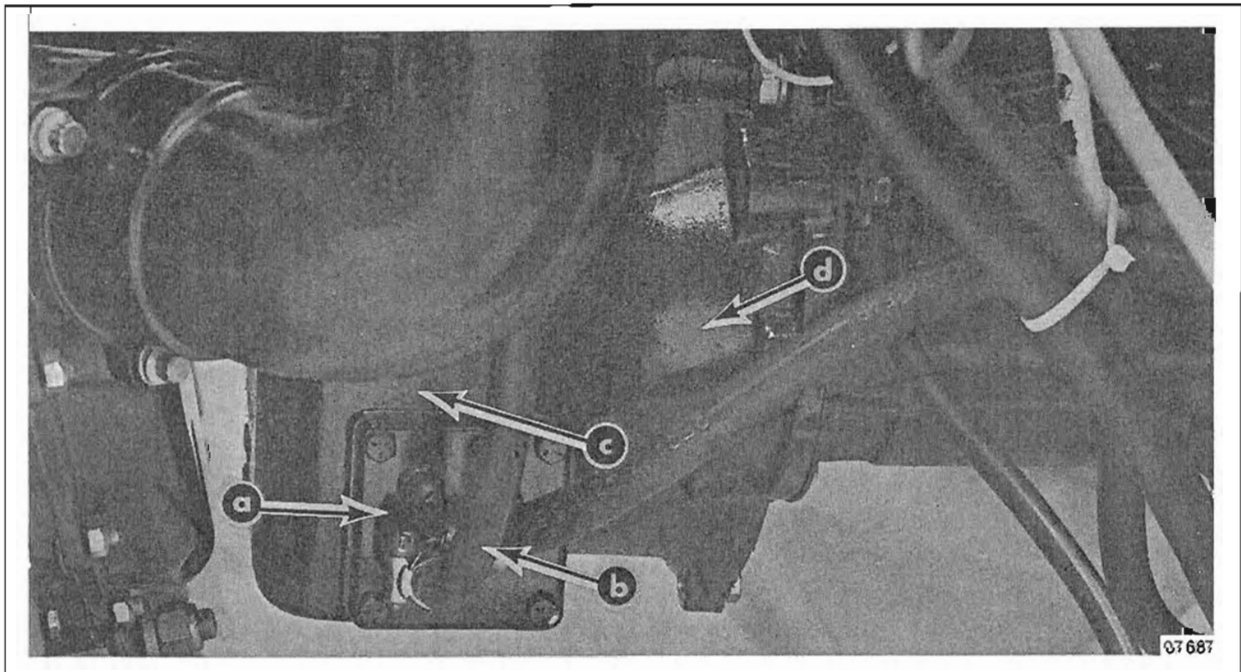
**Figure 1. Draining Transmission Oil Cooler**

The single, largest reason for the II-TR Transmission failure is improper draining and winterization in the fall of the year. The damage is not discovered until after running the unit the following spring. Help protect YOUR customers' investment by reminding them to properly service the unit BEFORE it freezes. THIS TRANSMISSION OIL COOLER IS NOT SELF-DRAINING.

1. Drain transmission oil cooler by removing outlet hose in Figure 1.
2. After water has been removed, reinstall hose.
