NUMBER: 84-11

- A. Acceleration "Bog" on MerCarb - MCM 120R/140R/470R/898R
- B. Hard Starting - MCM 488R
- C. Piston Clearance - MCM 470/485/488
- D. Connecting Rod/Piston Position with New Style Piston - MCM 470R/488R

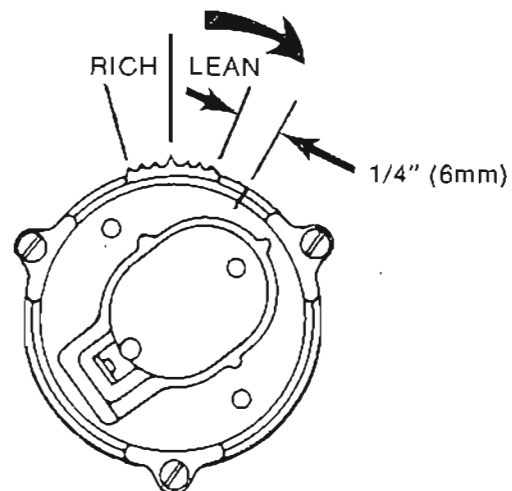
B. HARD STARTING - MCM 488R

If the engine is hard to restart after a 5 - 20 minutes shut down, do the following to correct the problem.

1. Install 1397-8548 SOLID needle and seat.
2. Reset float level to $\frac{3}{8}$ " (9mm).
3. Reset choke as shown.

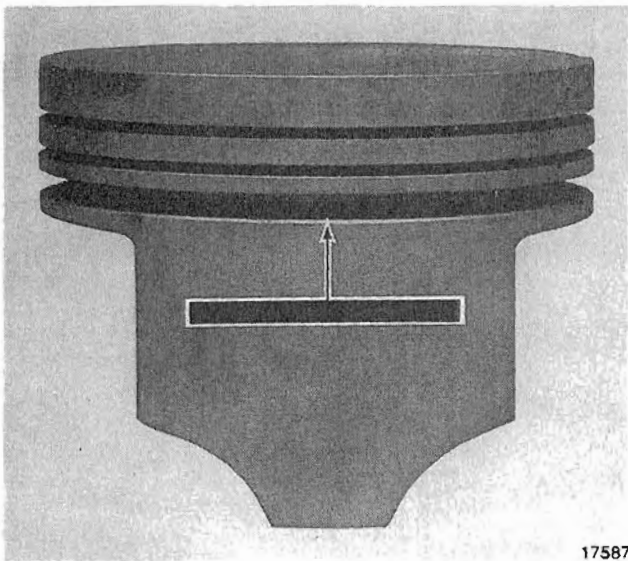
Pistons in Figures 1 and 2 can be mixed in an engine. Piston in Figure 3 **MUST NOT** be mixed with Figure 1 or 2 pistons in an engine.

Figure 1. .002" - .0037" (.05 - .09mm)

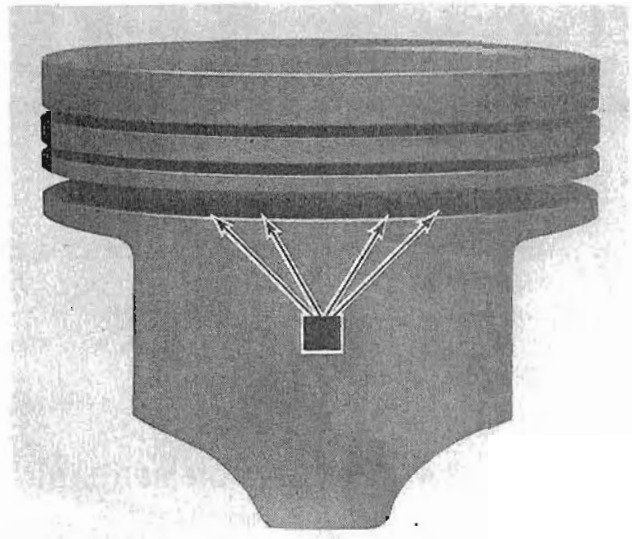
Figure 2. .004" - .0057" (.1 - .15mm)

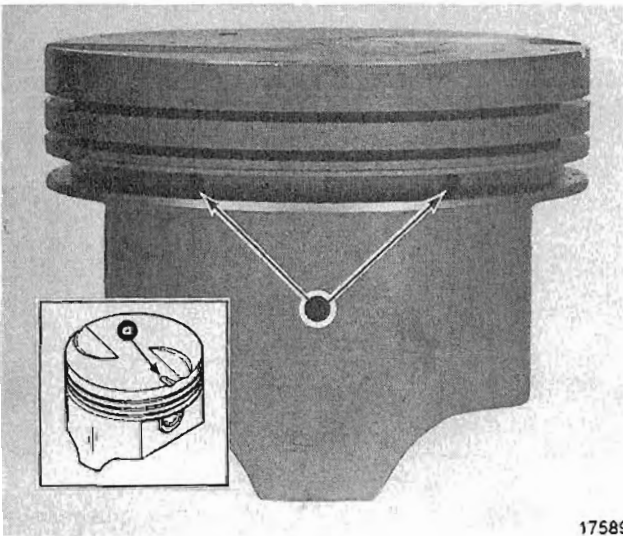
a - Notch
Figure 3. .001" - .0027" (.03 - .06mm)

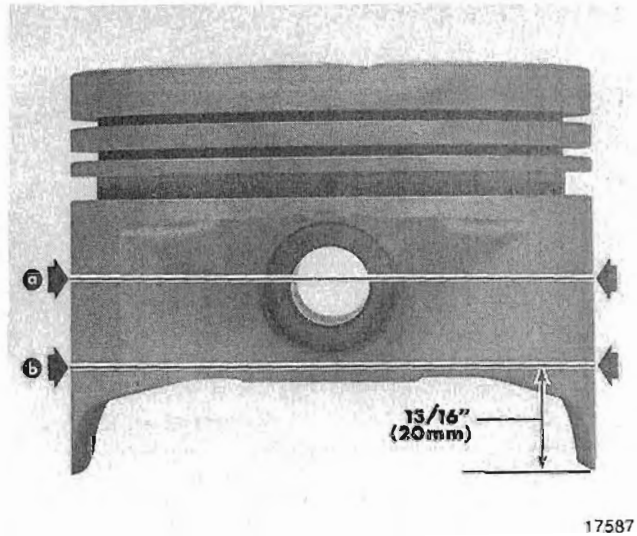
a - Figures 1 or 2 b - Figure 3
Figure 4. Clearance Location

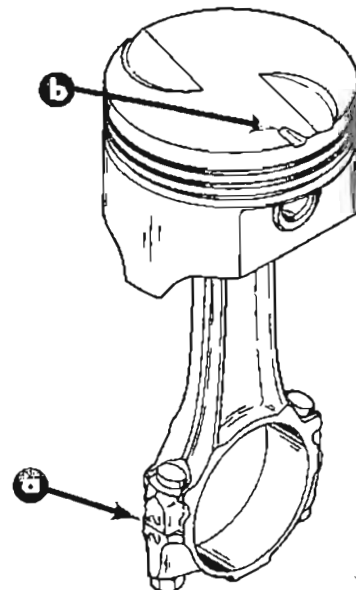
Figure 5.

The above model engines are using a new style piston. Refer to Figure 5 for assembling piston to connecting rod.

a - Number Toward Camshaft
b - Notch Toward Front
