BLACK MAX PROPELLER INSTALLATION

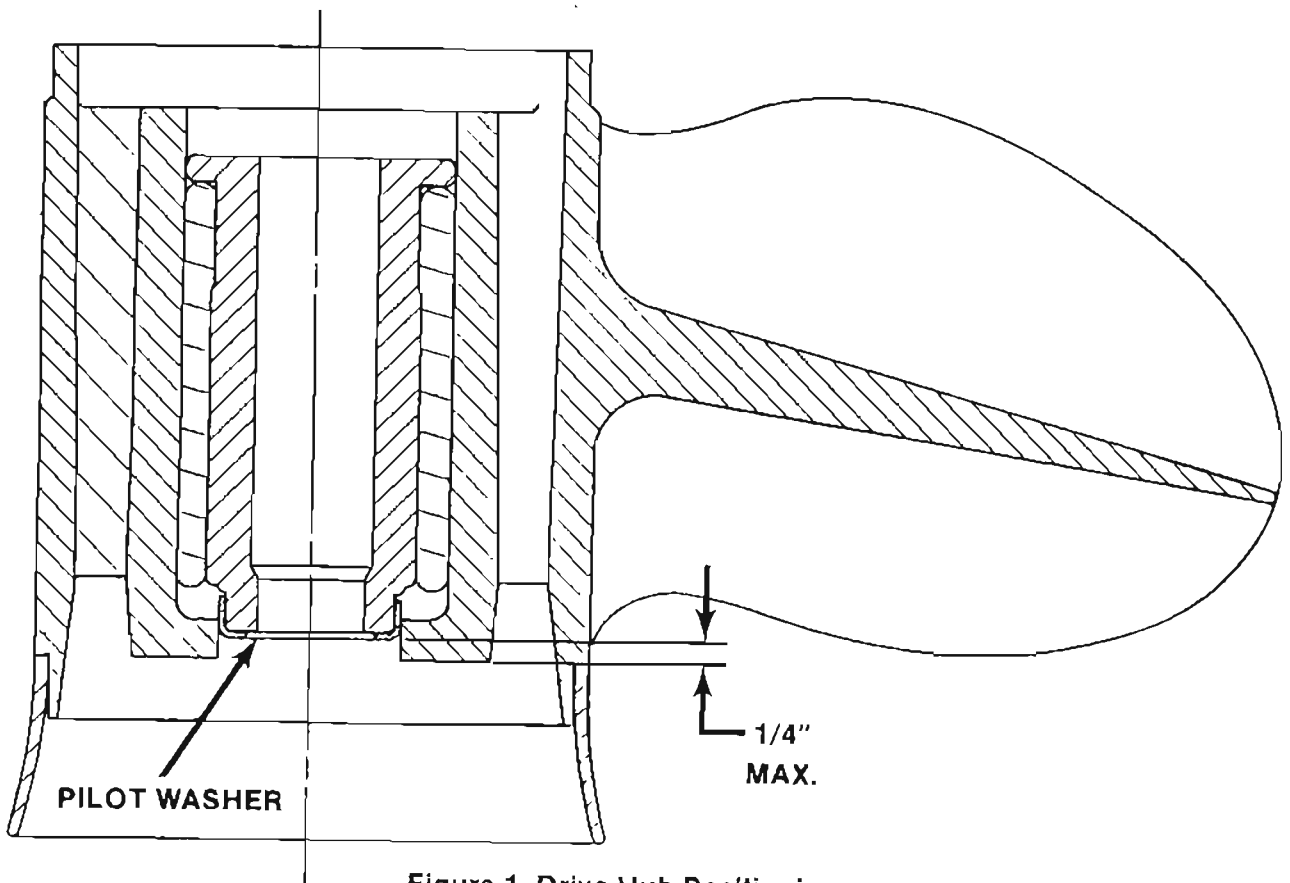
Occasionally we receive reports where the drive hub has backed out of the inner hub (in excess of the dimension shown in Figure 1), on Black Max aluminum and stainless steel propellers. This condition is observed after the propeller has been used for a period of time and then is removed from the propeller shaft. When this occurs the hub often cocks and it is no longer possible to reinstall the propeller, as the spline washer (Figure 2) will not align with the pilot hole in the propeller and/or engage with the spline on the propeller shaft.

Propeller must be rehubbled if the drive hub has backed-out to the point where spline washer cannot be installed.

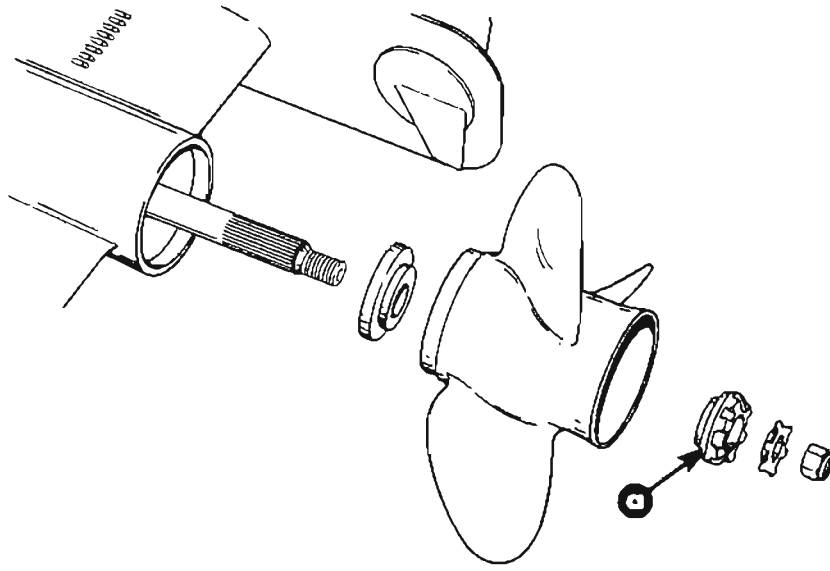
Figure 2. Propeller Installation

Our engineering department has inspected many of these cases and has determined that the problem is not caused by the propeller, but rather, by improper propeller installation. When installing Black Max propellers it is important to observe the following:

- Spline on spline washer must be engaged with spline on propeller shaft.
- Propeller nut must be torqued to 55 lbs. ft. (75 N.m) minimum.
