No. 87-6

Fuel Pump Leakage on MCM/ MIE V-8 Engines

Official Notification Under the U.S. Federal Boat Safety Act

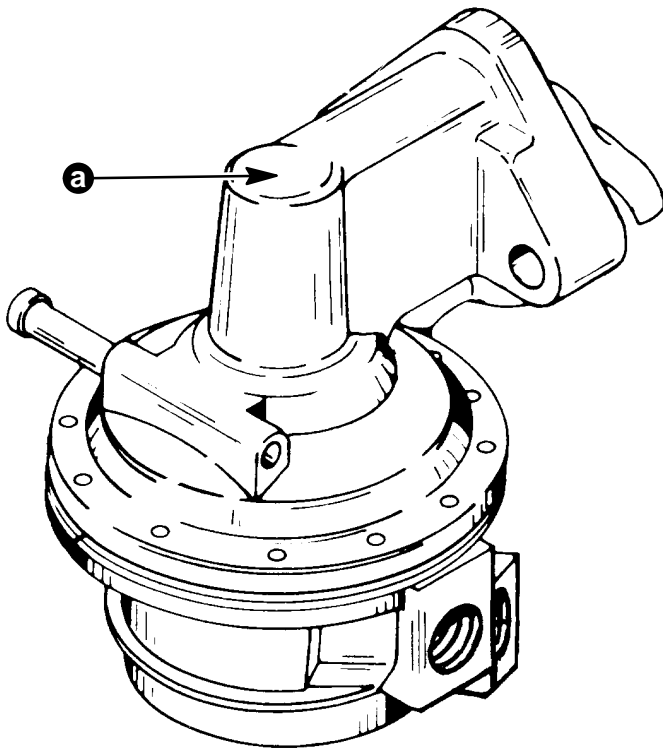
Figure 1. Fuel Pump Date Code Location

MerCruiser has determined that a possibility of a fuel leak exists on MCM/MIE V-8 engines equipped with fuel pumps stamped with date codes 2376 thru 2656. The date code can be located on the top of the fuel pump in the area shown in Figure 1.

a - Look in This Area for Date Code

If the fuel pump has a date code that falls between 2376 thru 2656 it must be replaced. Failure to do so may cause a fire and/or explosion. Part nos. for replacement fuel pump are as follows:

1. Disconnect fuel inlet line at fuel pump.
2. Disconnect fuel outlet line at fuel pump.
3. Disconnect sight tube from fuel pump.
4. Remove two mounting bolts and remove fuel pump.
5. Remove two fittings from fuel pump and install in new pump. Torque fittings to 15 lbs. ft (20 N.m).

6. Install new fuel pump. Torque mounting bolts to 20 lbs. ft (27 N.m).
7. Install sight tube.
8. Install inlet and outlet fuel lines and tighten securely.
9. Run engine and check for fuel leaks.

IMPORTANT: Place a dab of white paint on top of the fuel pump at date code location after inspection or replacement for future identification. This was done at the factory to fuel pumps that were inspected also. Fuel pumps with white paint need not be replaced.
