No. 87-4

MCM 420 Exhaust Pipe Repair and Installation

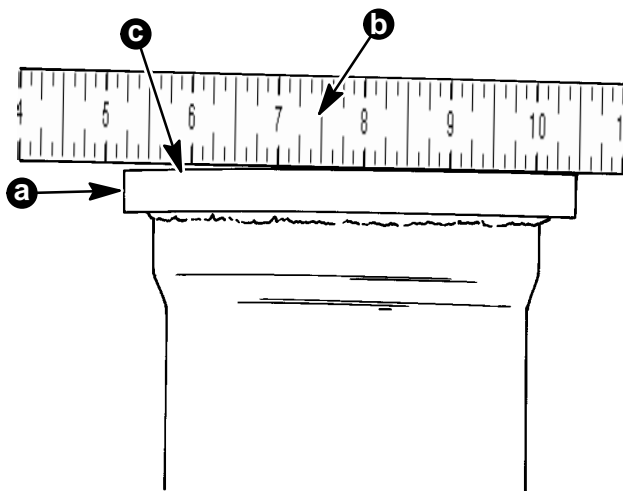
Figure 1. Checking Exhaust Pipe Flange

MerCruiser Service has received some reports of water entering the engine on MCM 420 engines. After investigation into the problem it was found that the mounting flanges on the stainless steel exhaust pipes may be warped. If this surface is warped water can leak into the exhaust system from between the exhaust pipe and exhaust elbow. All MCM 420 engines in the following serial number ranges should have the exhaust pipes removed and the mounting flange checked for warpage. (Figure 1)

- a - Flange
- b - Straight Edge
- c - Gasket Surface (Must Be Flat Within .010" (.25mm))

If the exhaust pipe flange is found to be warped the pipes should be sent to:

Order one new exhaust pipe kit (part no. 13851A11) per engine to replace pipes with warped flanges. This kit part no. will only be in affect for the term of this fix program.

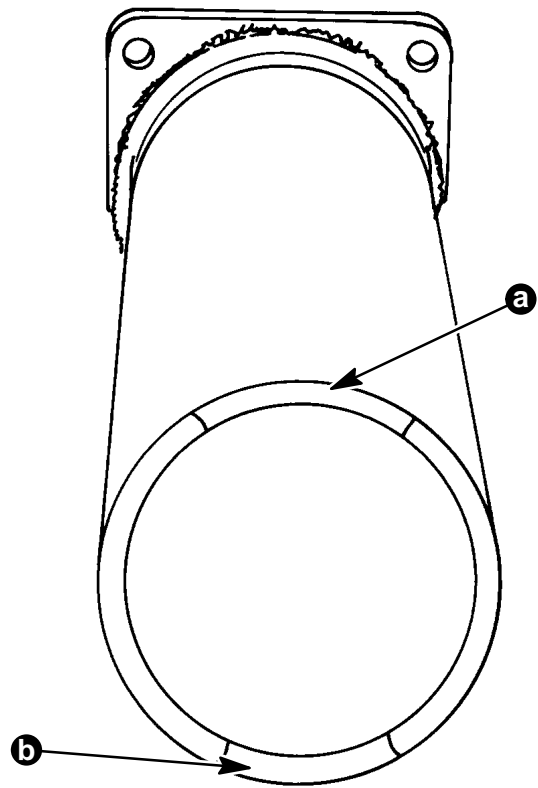
Figure 2. Proper Exhaust Pipe Installation

When installing the 420 exhaust pipes it is imperative the pipes be installed properly or exhaust hose burning may be experienced. The exhaust pipe must be installed with a water discharge slot at the 12 o'clock position and a weld at the 6 o'clock position. (Figure 2) Failure to do so may cause hot spots on the upper half of the exhaust hose. Future exhaust pipes will be stamped "top" on the mounting flange for ease of correct installation. After installing the pipes properly if they are not marked "top" place an "X" on the top surface of the exhaust flange.

- a - Water Discharge Slot at 12 O'clock
- b - Weld at 6 O'clock
