No. 88-9

Power Trim Control P/N 55642A13 Assembled Wrong

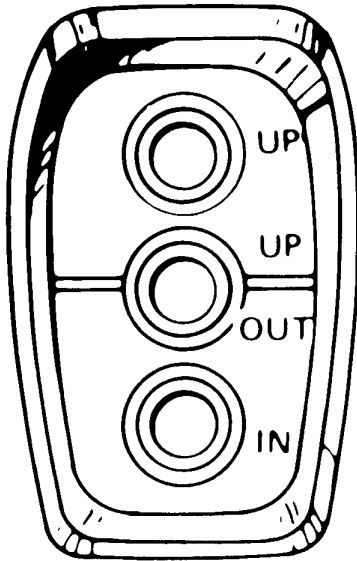
Figure 1.

There may be some three button Power Trim Controls P/N 55642A13 manufactured with the panel face mounted wrong. Symptoms of the incorrect panels are; push the "UP" button, drive unit will go down "IN", push the down "IN" button, drive unit will go "UP". (Figure 1) To correct this problem remove control panel from dash (if installed in boat), remove four retainer screws, turn panel face 180° and re-install retainer and screws. (Figure 2)

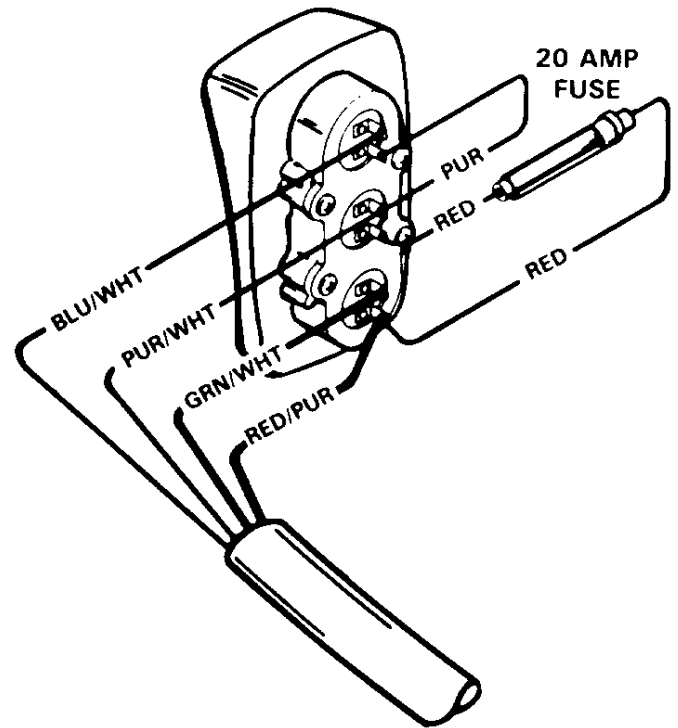
Figure 2.

- a - Retainer
- b - Retainer Screws (4)
