No. 90-17

## A. REPLACEMENT OF GIMBAL HOUSING STUDS JUST BELOW THE INNER TRANSOM PLATE ENGINE SUPPORTS ON ALPHA ONE GENERATION II TRANSOM ASSEMBLY

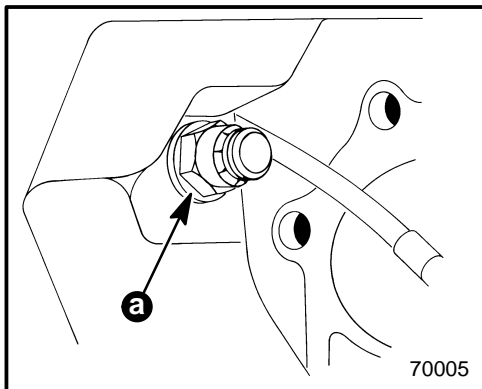
The studs just below the inner transom plate engine supports are too long and may rub on the lower exhaust pipe causing it to wear through.

a - Locknuts and Flat Washers

Replace studs-washers and elastic stop nuts (a) with bolts-lockwashers and square flat washers (b) as shown, and torque to 20-25 lb. ft. (27-34 N.m).

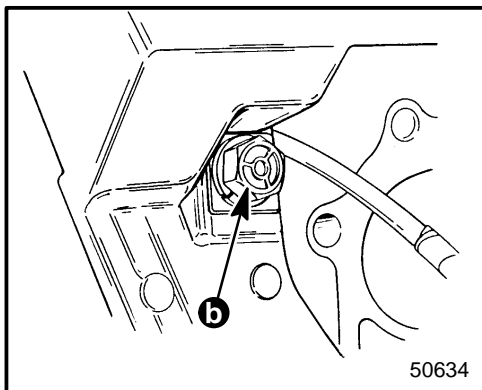
b - 4-1/4 in. (108mm) Long Bolts Lockwashers and Square Flat Washers (2)
