No. 90-14

Possible Cause for Engine Overheating

All Bravo Stern Drive Engines (Gasoline or Diesel)
Serial Number: All

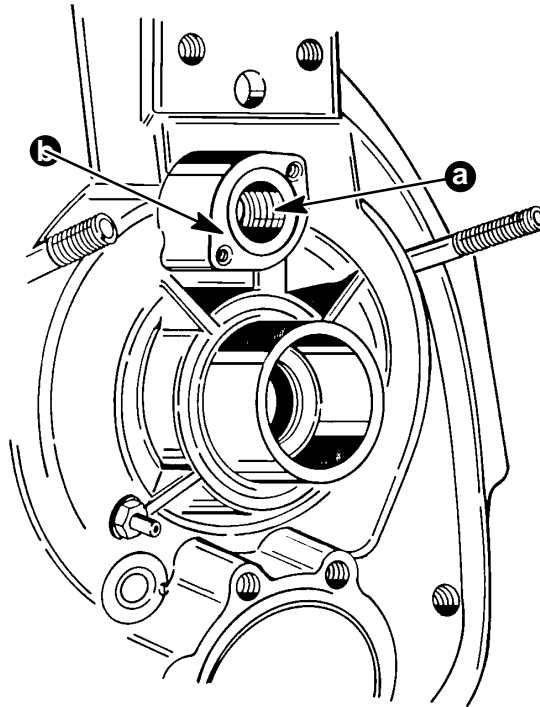
22080

NOTE: This problem usually occurs in saltwater areas only. If you are having an engine overheating condition that you can't solve, please check the following as a possible cause.

Remove engine water inlet fitting from the gimbal housing. Inspect tapered insert and water hose (a) to see if they have collapsed. If these parts have collapsed, reduced water flow will be supplied to the engine.

Follow repair procedure as outlined in Section 4A of Number 11 MerCruiser Service Manual. Clean all salt deposits out of water hose cavity in gimbal housing.

Install hose so that it is 1/16 in. (2mm) from machined surface (b) on gimbal housing. Install insert.

IMPORTANT: Make sure hose is not twisted or kinked after installing insert.

To keep saltwater from getting between the hose and housing, apply a 1/16 in. (2mm) bead of approved sealer around the hose's edge and housing cast hole. Don't get any sealer on machined surface (for water inlet fitting). Follow direction on approved sealant for curing time.
