service bulletin

No. 90-19

A. POSSIBLE DIFFICULTY SHIFTING OUT OF GEAR ON BRAVO DRIVE 1.36:1 AND 1.81:1

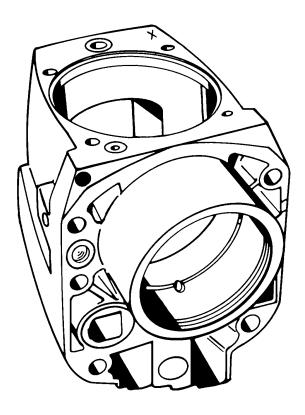
50306

The drive shaft housing must be marked at two locations: on the left rear top corner under the top cover (A) with an "X", and on the right front surface (B) with a white paint dot 1/2" in diameter as shown in figure 2.

Remove and replace both driven gears with new ones from service kit 43-815662A4. The new gears will be identified as shown in Figure 1 with an "A" next to the "+" (plus sign) on the bronze ring.
