No. 90-13

## A. OIL LEAK AT FRONT OF ENGINE

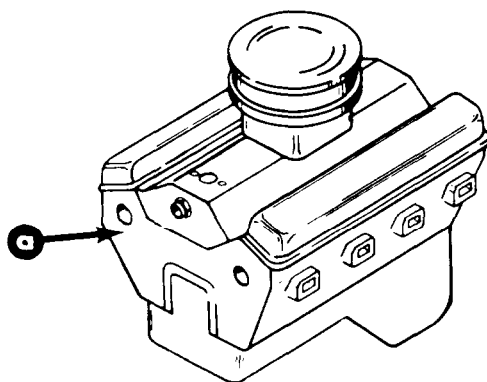
a - V6 (Front, Starboard Side, Near Cylinder Head Mating Surface) – T02280KP/KR - T05290KPIKR  
February 28, 1990 to May 29, 1990 build date

Check engine CODE on front of engine. Repair only the engines that are within the date codes shown below.
