No. 91-4

A. 815471A3 BRAVO SHIFT CABLE REPLACEMENT KIT

5.7 I/7.4L/454 Mag./502 Mag./HP465/D183 Turbo AC/D219 Turbo AC/D254 Turbo AC

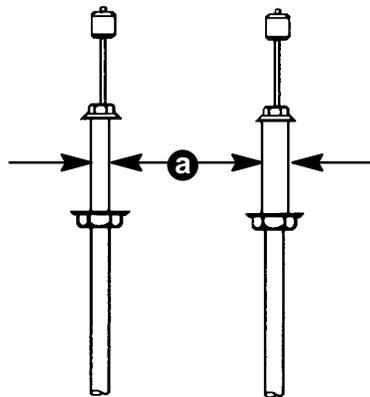
70377

1. Remove Stern Drive and Shift Cable as outlined in the appropriate sections of the Bravo Stern Drive Unit, Service Manual.
2. Compare the shift cable that was removed from the unit with the replacement shift cable.
 - a. If diameter "a" is equal on both the removed cable, and the replacement cable, install the replacement cable as outlined in the Bravo Stern Drive Unit, Service Manual. Disregard all of the following instructions.
 - b. If the diameter "a" is larger on the replacement shift cable than on the removed shift cable, proceed with the following instructions.

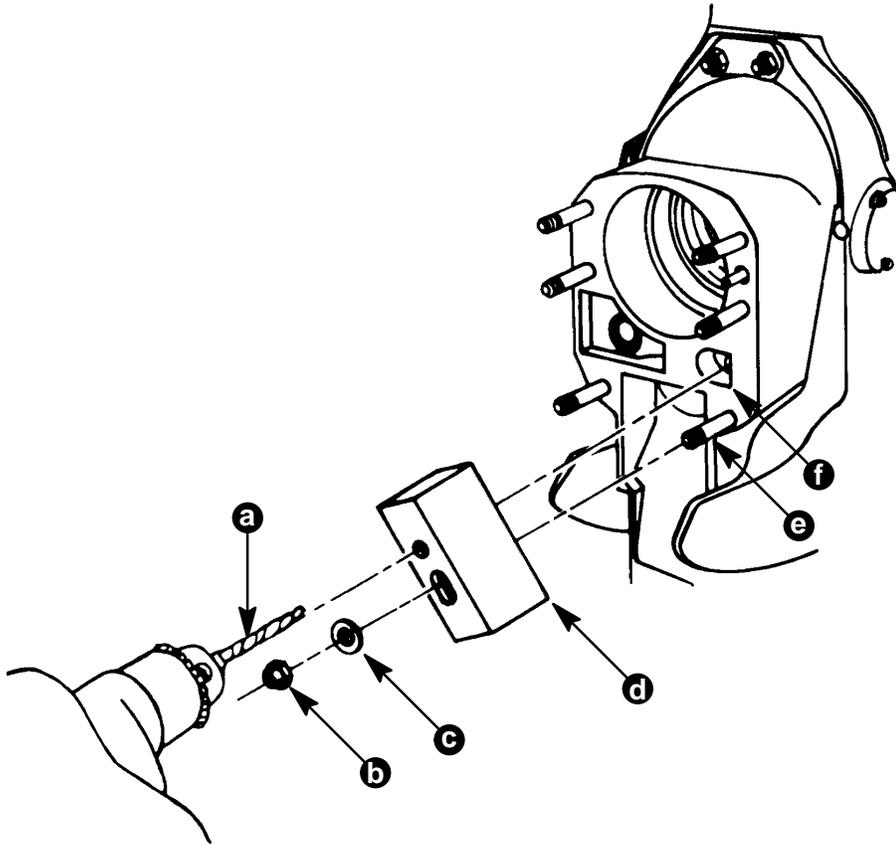
70378

The drill used to drill this hole must be sharp, without nicks, straight, and have a 118° point. Failure to use the proper drill may cause a rough surface in the newly drilled hole. This could cause water to leak through the Bell Housing and into the Drive Shaft Housing, which could cause premature failure to the shift components.

4. Using the 7/16 in. drill provided with the service tool kit, P/N 91-818836A-1, drill through the 7/16 in. hole of the bushing tool and through the Bell Housing shift cable bore.
