No. 92-2

A. TRIM PUMP 110 AMP FUSE

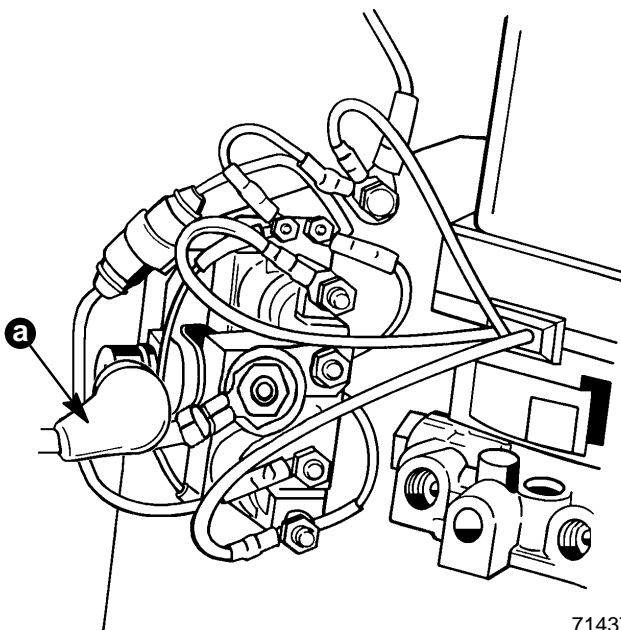
71437

The Trim Pump mainly on new boats may function several times and then quit working, this condition is caused by the loctite wicking and isolating the washer and nut from the bolt, causing a loss of electrical contact to the large red lead in turn causing the Trim Pump to stop working.

When this happens first disconnect the red Trim Pump lead from the battery end, then slip the black rubber boot (a) on the large red lead away from the fuse and remove nut (b) and lead assembly (c) from the bolt on the fuse and clean the loctite from the bolt with a wire brush, then reinstall the lead assembly and tighten the nut.

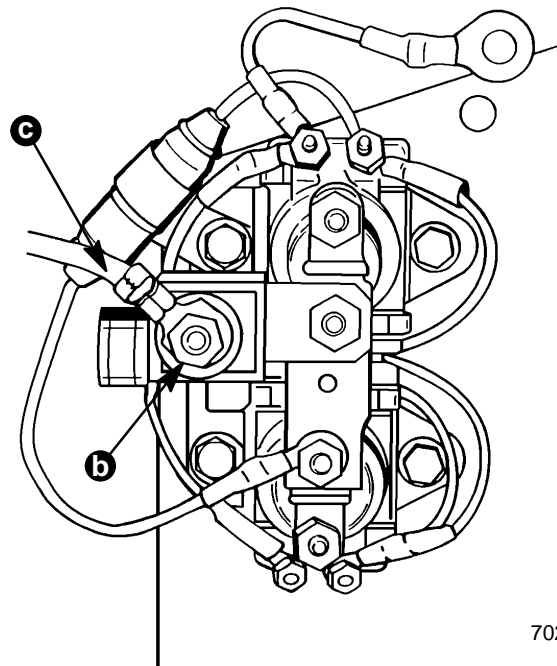
70232

The 110amp fuse has had two changes made to improve the assembly.

1. The phenolic washer was replaced by a steel washer.
2. The loctite used on the nut directly behind the washer has been eliminated and replaced with a locking nut.
